22 BOCLAIR CRESCENT
BEARSDEN
GLASGOW
G61 2AG

Home Report

Scottish Single Survey

Report date 27th May 2022

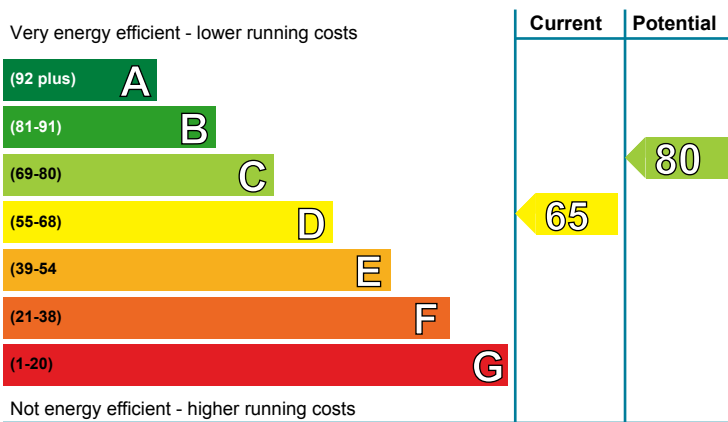
Energy Efficiency Rating

Your current rating is **band D (65)**. The average rating for EPCs in Scotland is **band D (61)**.

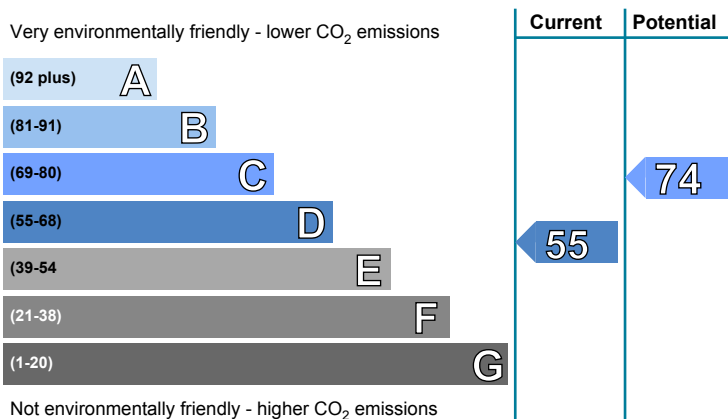
Environmental Impact (CO₂) Rating

Your current rating is **band D (55)**. The average rating for EPCs in Scotland is **band D (59)**.
