YOUR ONESURVEY HOME REPORT

Flat 1
28 Cleveden Drive
Glasgow
G12 0RX

SINGLE SURVEY

Prepared by	Andrew McCall, BSc (Hons) MRICS Glasgow North - Allied Surveyors Scotland Ltd
--------------------	--

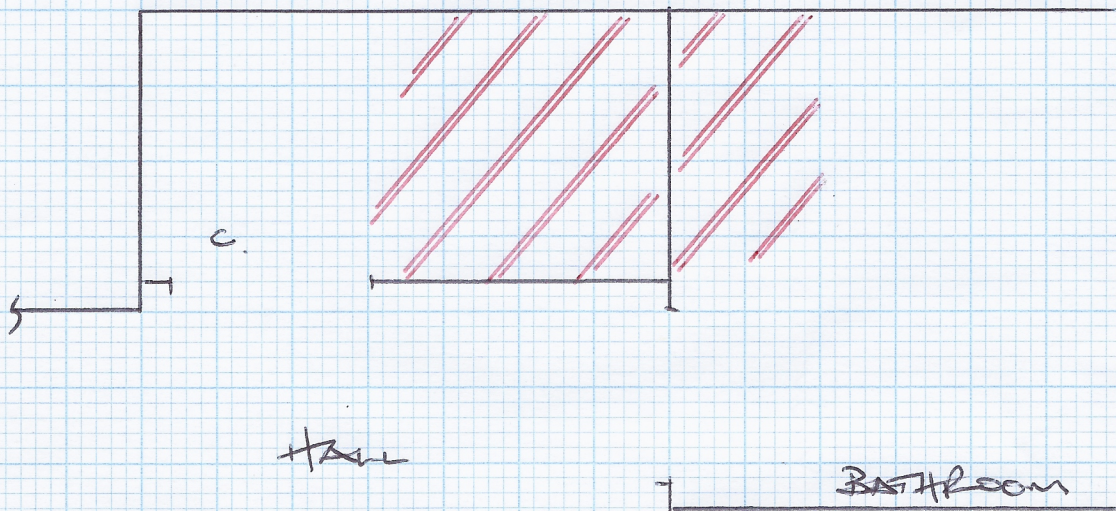
28 CLEVEDEN DRIVE
GLASGOW.

Dampness, rot and infestation	
Repair category:	2
Notes:	Sections of decayed timbers were noted in the sub floor space below the bathroom. This appeared to be as a result of a leak. An inspection has been carried out by a licensed timber and damp specialist and repairs have been estimated. The vendor states these works will be carried out prior to sale. This should be confirmed. There is evidence of previous rot repairs in the sub floor space. Any documentation relating to these should be retained.

Floors including sub-floors	
Repair category:	2
Notes:	Sections of decayed timbers were noted below the bathroom. See comments under dampness, rot and infestation.

RENEW FLOORING, JOISTS & WALLPLATES
AFFECTED BY DECAY.
