Home Report

Single Survey

Property address	1/2 63 Lauderdale Gardens Glasgow G12 9QU
Customer	J & M McGettrick
Customer address	1/2 63 Lauderdale Gardens Glasgow G12 9QU
Prepared by	Shepherd Chartered Surveyors
Date of inspection	11/02/2025

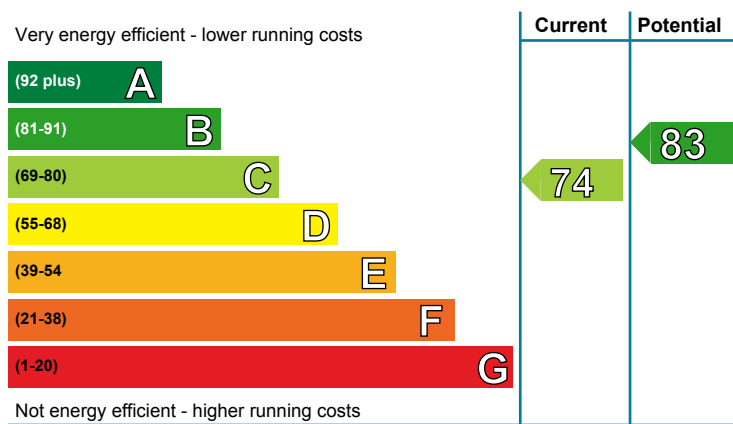
Energy Efficiency Rating

Your current rating is **band C (74)**. The average rating for EPCs in Scotland is **band D (61)**.
