Home Report

Single Survey

Property address	2 Mill Hall The Old Mill Eaglesham G76 0PD
Customer	SUSAN LORIMER
Customer address	2 Mill Hall The Old Mill Eaglesham G76 0PD
Prepared by	Shepherd Chartered Surveyors
Date of inspection	12/03/2025

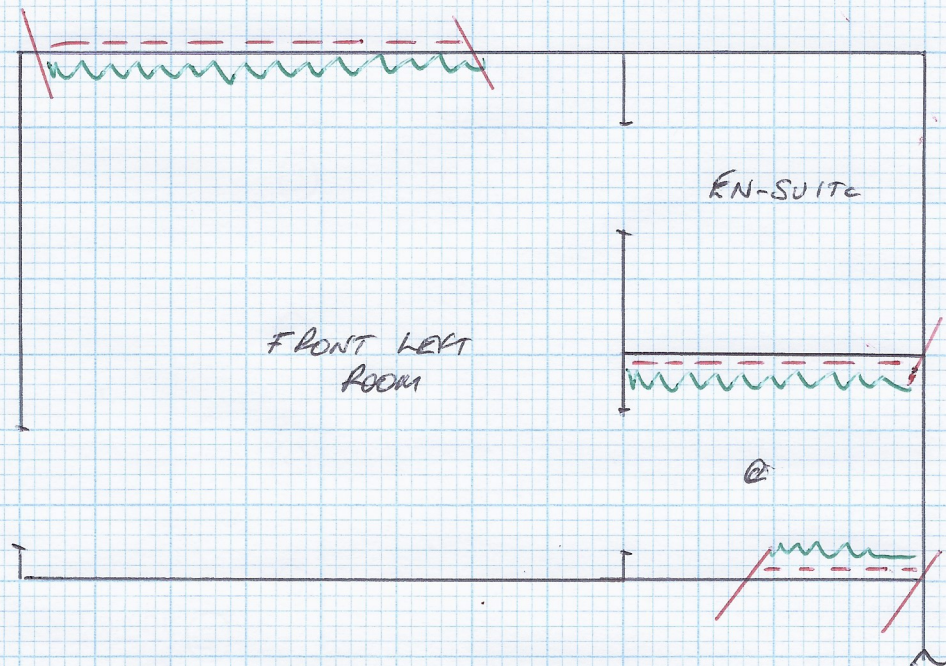
—— VERTICAL DPC

~~~~~ REPLASTER/MEMBRANE 1m HIGH

RECOMMENDATIONS
