Home Report

Single Survey

Property address	24 Alder Road Glasgow G43 2UU
Customer	Thenue Housing Association
Customer address	24 Alder Road Glasgow G43 2UU
Prepared by	Shepherd Chartered Surveyors
Date of inspection	27/03/2025

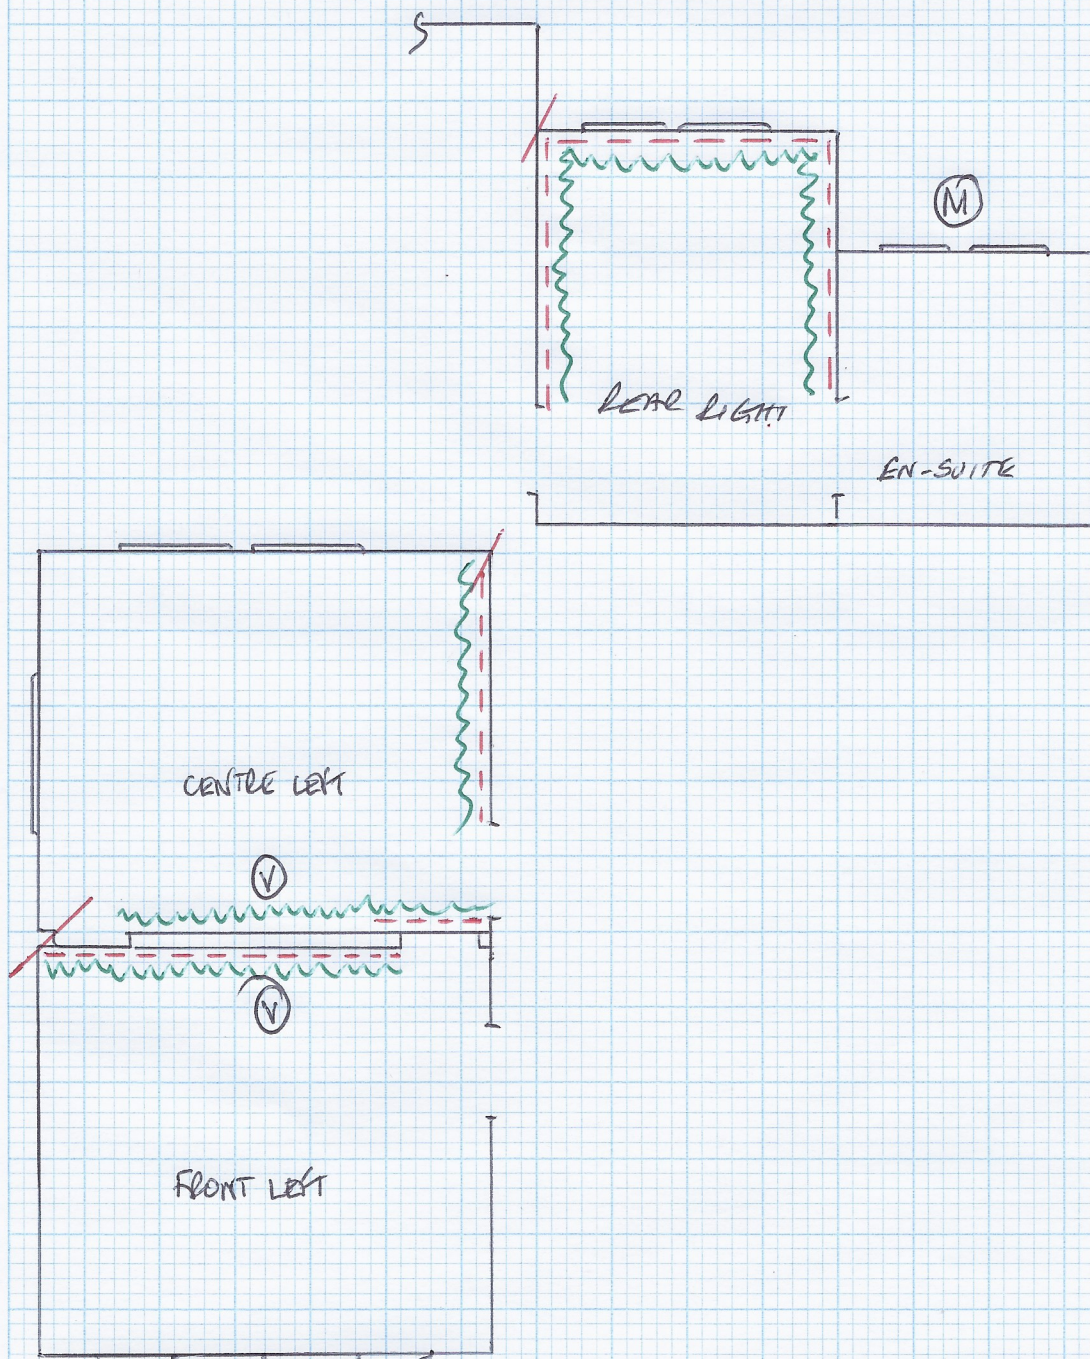
Ⓜ RENEW CONCRETE MULLION

Ⓟ FIT NEW VENTS
