Flat C,
78 Montgomery Street,
Irvine,
Ayrshire,
KA12 8PW

Home Report

Single Survey

Property Address	Flat C, 78 Montgomery Street, Irvine, Ayrshire, KA12 8PW
Reference	1018153
Customer Name	Rhona Macgregor
Date of Inspection	14th April 2025
Surveyor's name, qualifications and office	Greg Fisher BSc (hons) MSc MRICS DM Hall LLP Chartered Surveyors 45 Bank Street Irvine KA12 0LL Tel: 01294 311070 email: irvineresidential@dmhall.co.uk
Prepared By	DM Hall LLP

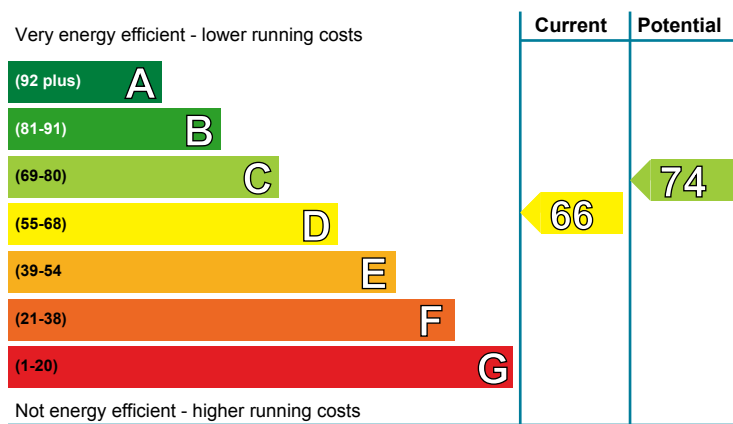
Energy Efficiency Rating

This graph shows the current efficiency of your home, taking into account both energy efficiency and fuel costs. The higher this rating, the lower your fuel bills are likely to be.

Your current rating is **band D (66)**. The average rating for EPCs in Scotland is **band D (61)**.

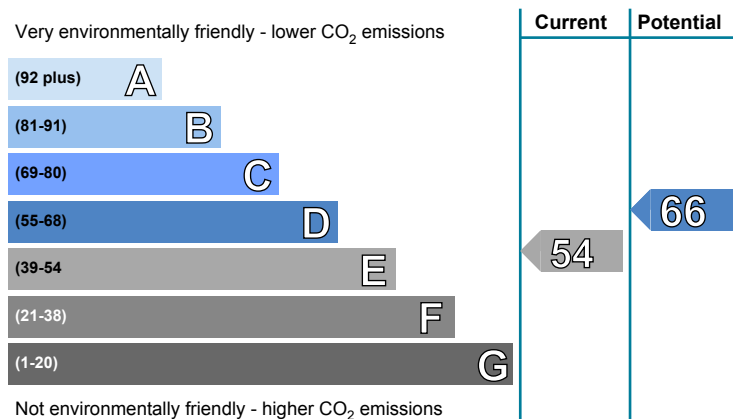
Environmental Impact (CO₂) Rating

This graph shows the effect of your home on the environment in terms of carbon dioxide (CO₂) emissions. The higher the rating, the less impact it has on the environment.
