YOUR ONESURVEY HOME REPORT

15 Ashton Road
Glasgow
G12 8SP

SINGLE SURVEY

Date of Inspection	09/04/2025
---------------------------	------------

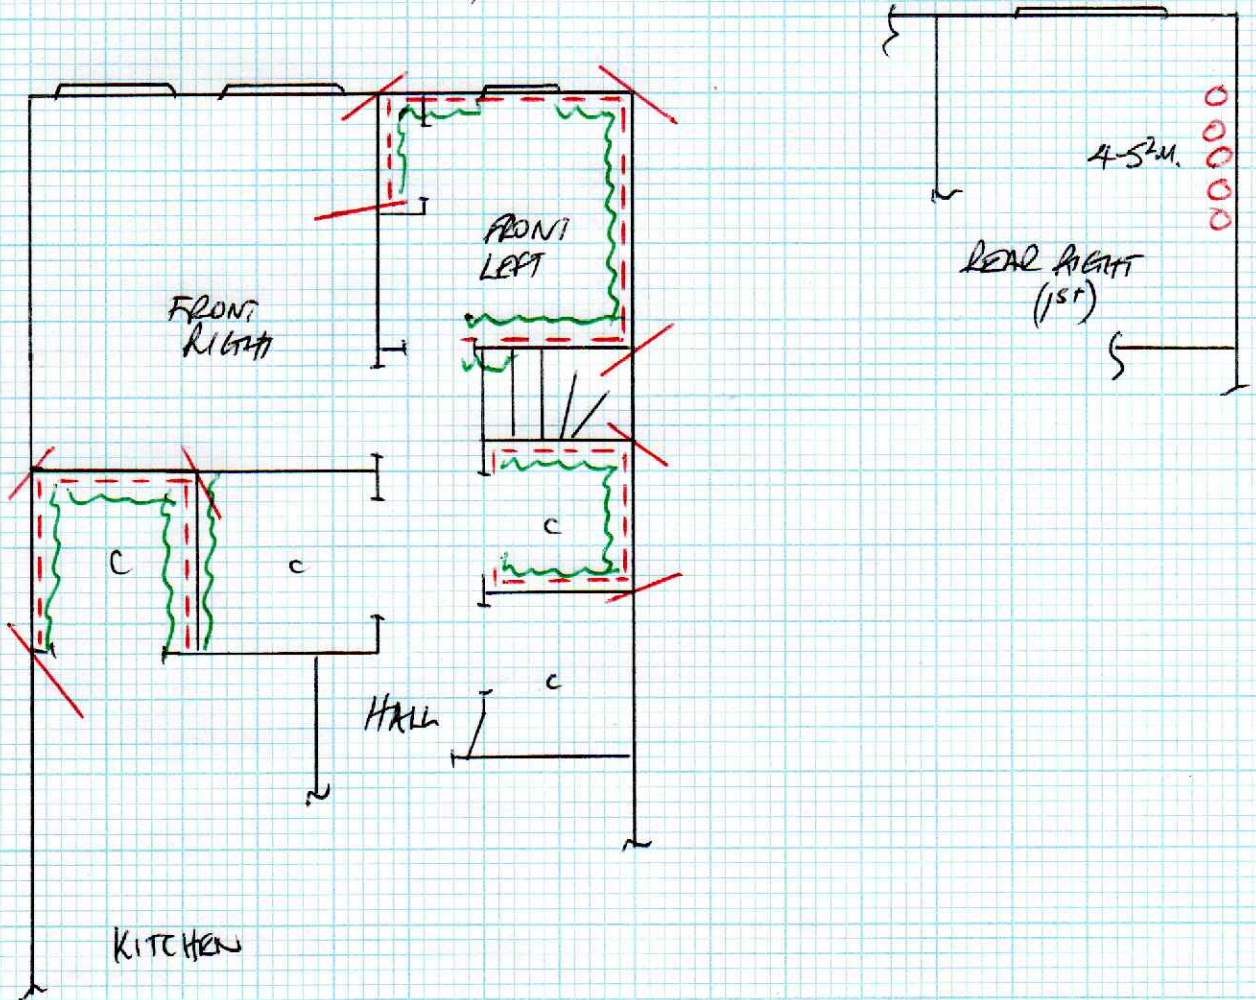
~~~~~ REPLASTER/MEMBRANE UP TO 1m HIGH

oooo REPLASTER/SURFACE TREAT WALL.
