Home Report

Single Survey

Property address	5 Pentland Road Glasgow G43 2AR
Customer	Zina Mula
Customer address	5 Pentland Road Glasgow G43 2AR
Prepared by	Shepherd Chartered Surveyors
Date of inspection	03/06/2025

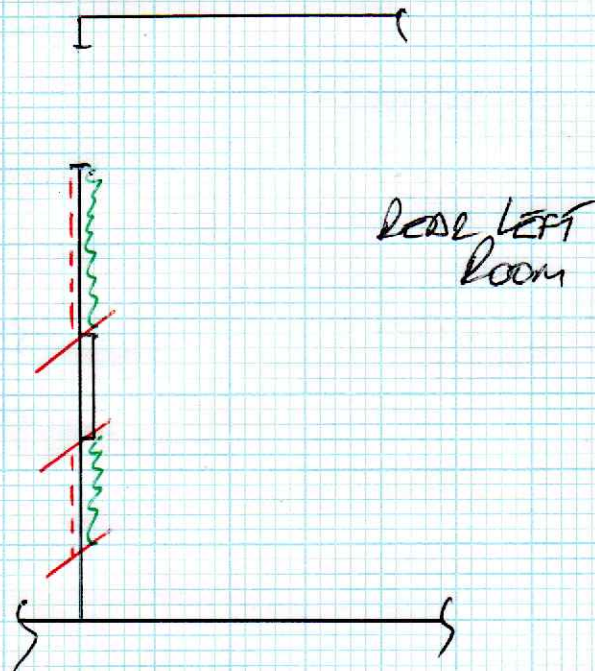
SPENTLAND ROAD
GLASGOW

- DAMP PROOF COURSE
- VERTICAL DPC
- www REPLASTER/MEMBRANE UP TO 1M HIGH

Quotation For Recommended Treatments:- £1,096 + VAT
