# YOUR ONESURVEY HOME REPORT

Inglefield  
14 Oakley Drive  
Netherlee  
Glasgow, G44 3PY

# SINGLE SURVEY

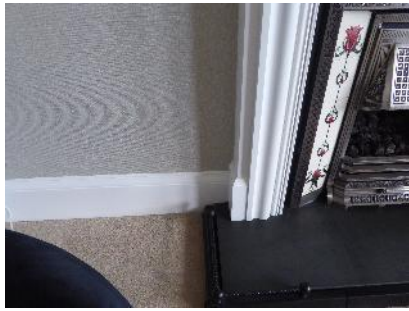
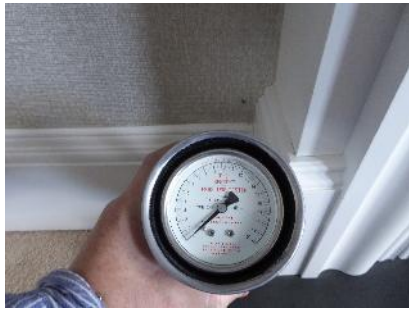
Sample 1 Location

Location	Sample Position	Moisture Content (% MC)	Interpretation
Lounge	Left of Fireplace	0.02%	Dry
Lounge	Right of Fireplace	0.1%	Dry
Sitting Room	Right of Press	0.1%	Dry

**Industry Standard Note:** Moisture content readings below 5% are generally considered dry for plastered walls. In older properties, a reading of up to 2-3% can often be considered acceptable and is typically due to residual background moisture. The readings obtained (0.0% - 0.1%) are significantly below any threshold of concern.
