# Home Report

# Single Survey

| Property address | 0/1<br>802 Pollokshaws Road<br>Glasgow<br>G41 2AY |
| Date of inspection | 01/10/2025 |

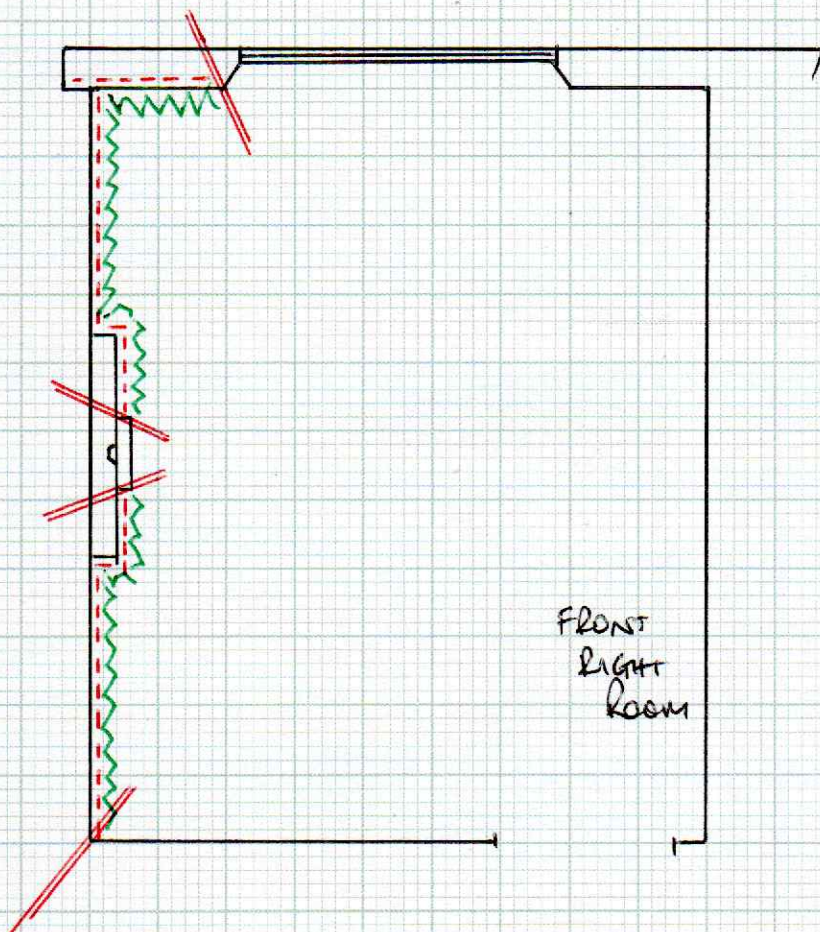
802 POLLOKSHAW ROAD  
GLASGOW

REPLASTER & CAVITY  
MEMBRANE UP TO 1M HIGH
