Home Report

Property address	0/2 32 Cartside Quadrant Glasgow G42 9TH
Customer	ERIN SCHUURS
Customer address	0/2 32 Cartside Quadrant Glasgow G42 9TH
Prepared by	Shepherd Chartered Surveyors
Date of inspection	07/01/2026

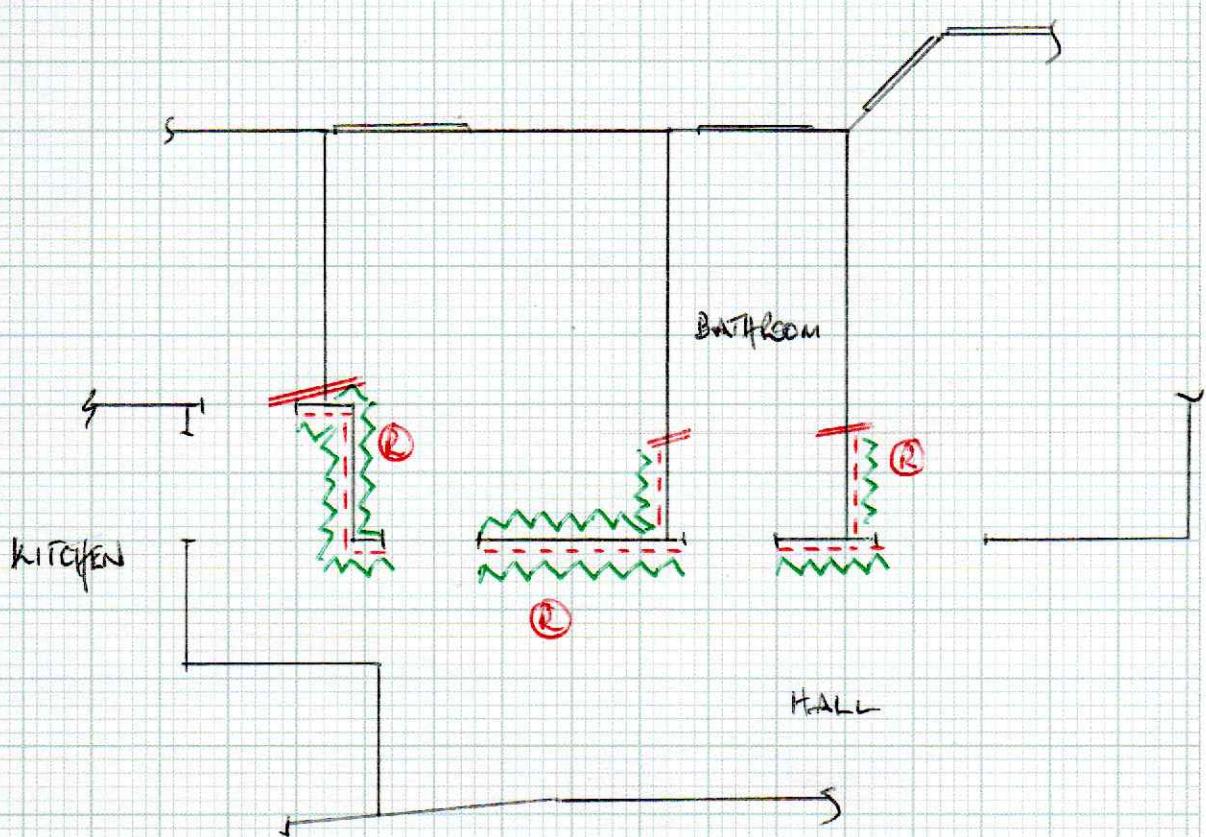
0/2, 32 CARTSIDE QUAD
GLASGOW.
G42 9TH.

REPLASTER & CAVITY
MEMBRANE UP TO 1M HIGH

① CLIENT TO REMOVE/RE-FIT RADS
