# Home Report

| Property address | 108 Tantallon Road<br>Glasgow<br>G41 3LY |
| Date of inspection | 04/03/2026 |

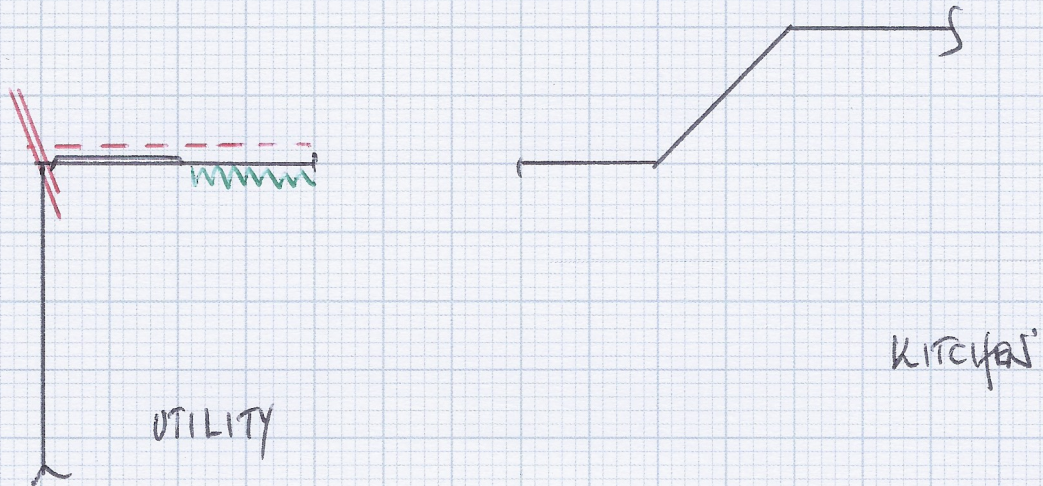
108 TANTALLON ROAD  
GLASGOW

REPLASTER & CAVITY  
MEMBRANE UP TO 1M HIGH

REPLACE SMALL \*  
OF PLASTER.  
100mm x 100mm
