Roselea,
4 Castle Street,
IRVINE,
KA12 8RJ

Home Report

Single Survey

Property Address	Roselea, 4 Castle Street, IRVINE, KA12 8RJ
Reference	1552123
Customer Name	Kay Bennett
Date of Inspection	29th April 2026
Surveyor's name, qualifications and office	Greg Fisher BSc (hons) MSc MRICS DM Hall LLP Chartered Surveyors Eldo House, Monkton Road, Prestwick, KA9 2PB Tel: 01292 286974 email: ayrshireresidential@dmhall.co.uk
Prepared By	DM Hall LLP

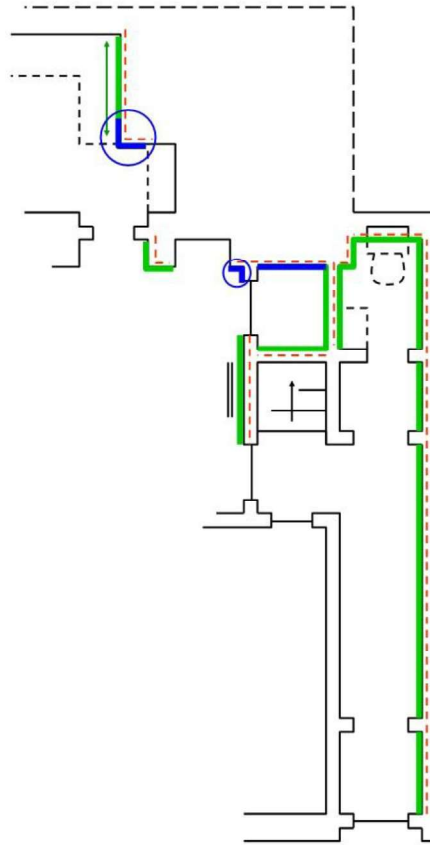
Part Ground Floor Plan

Chemical DPC
