# Home Report

# Single Survey

| Property address | 346 Kilmarnock Road<br>Glasgow<br>G43 2DQ |
| Date of inspection | 23/07/2026 |

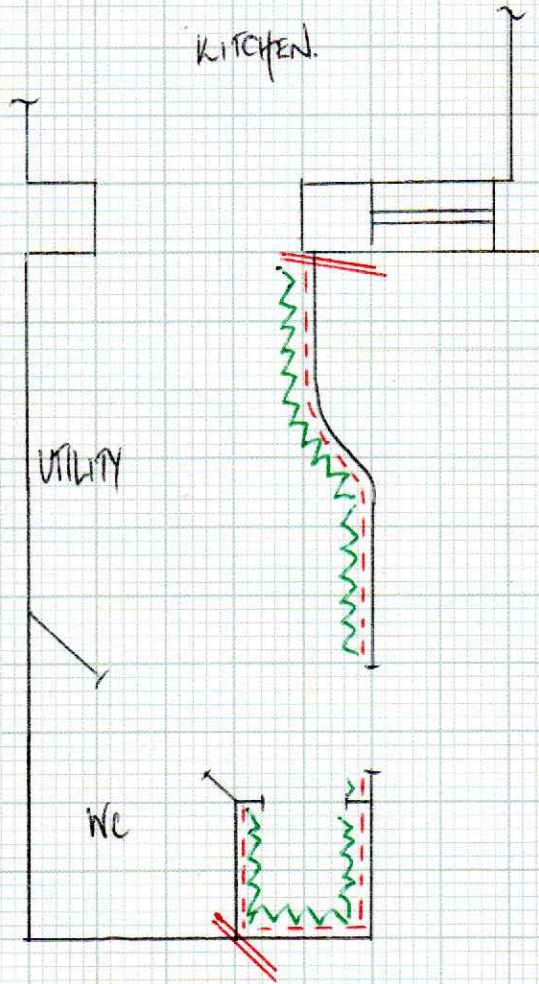
346 KILMARNOCK ROAD  
GLASGOW.

REPLASTER & CAVITY  
MEMBRANE UP TO 1M HIGH
