# Home Report

survey report on:

| Property address | 0/1<br>4 Glencairn Drive<br>Glasgow<br>G41 4QN |
| Date of inspection | 18/09/2026 |

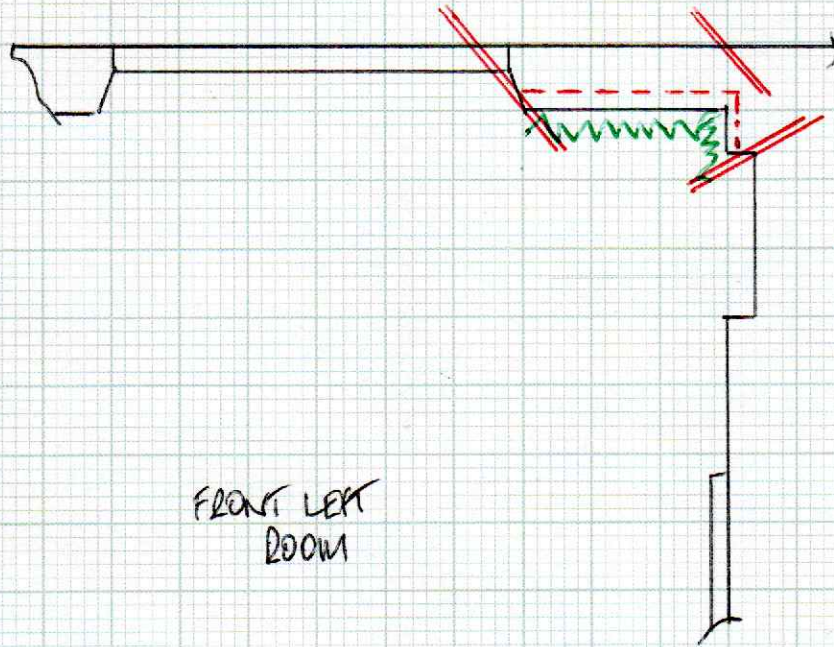
FRONT LEFT  
ROOM

Above average damp readings were obtained to localised sections of lower wall lining within the living room and bedroom four. The vendor instructed Allied Timber and Damp Specialists to inspect the property in relation to internal dampness and have provided a report dated 24th September, which has been provided within the Appendices of this Home Report. All recommendations should be carried out to a guaranteed standard at the earliest opportunity.
