Home Report

8 SOMERSET PLACE MEUSE
GLASGOW
G3 7JS

Single Survey

Property address	8 SOMERSET PLACE MEUSE GLASGOW G3 7JS
Customer	Mr D Rowling
Customer address	
Prepared by	White Horse Surveyors Limited
Date of inspection	22nd July 2020

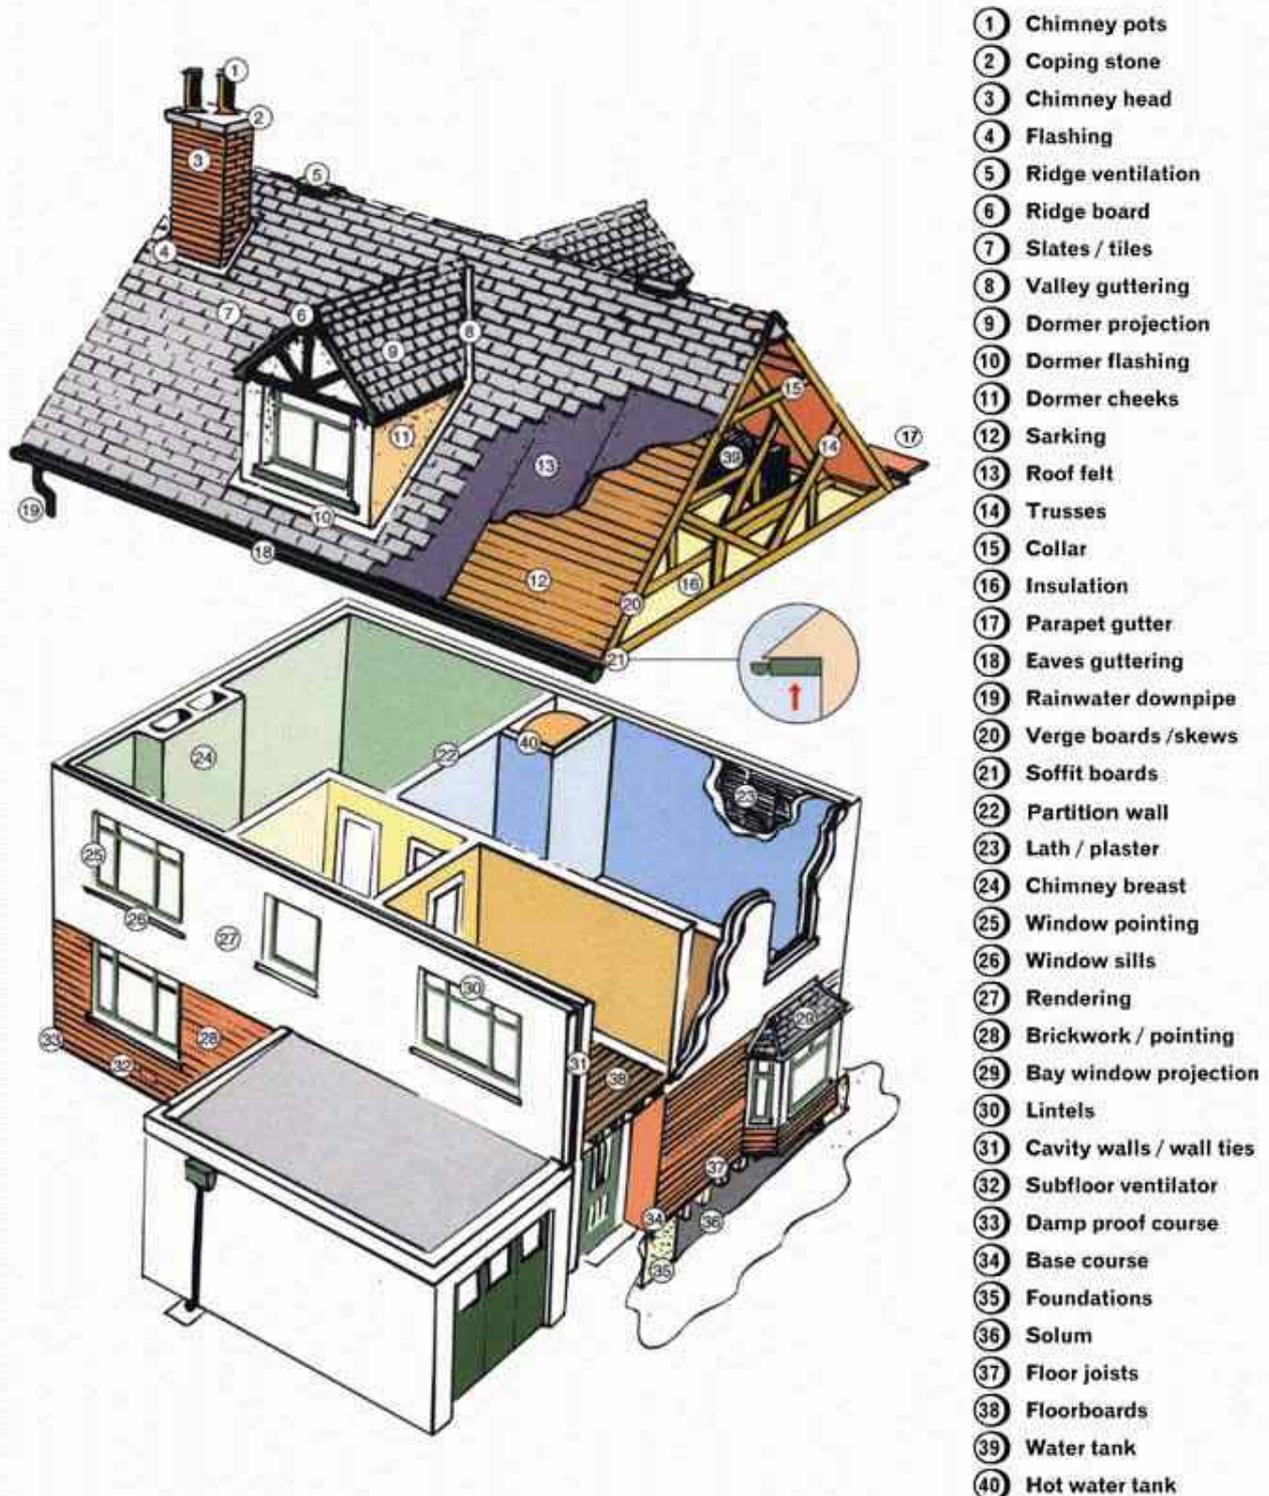
Sectional Diagram showing elements of a typical house

Reference may be made in this report to some or all of the above component parts of the property. This diagram may assist you in locating and understanding these items.

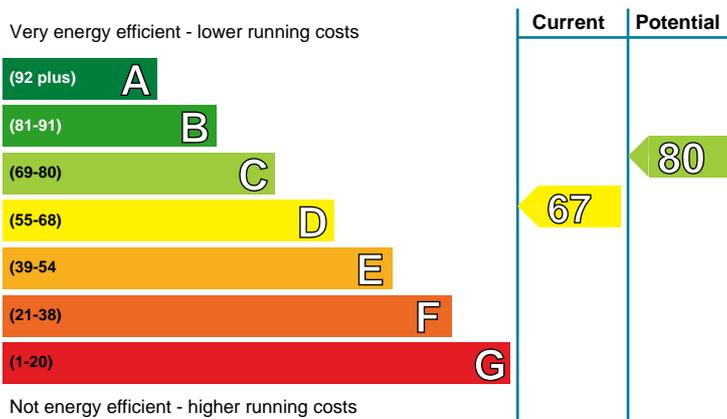
Energy Efficiency Rating

This graph shows the current efficiency of your home, taking into account both energy efficiency and fuel costs. The higher this rating, the lower your fuel bills are likely to be.

Your current rating is **band D (67)**. The average rating for EPCs in Scotland is **band D (61)**.

The potential rating shows the effect of undertaking all of the improvement measures listed within your recommendations report.

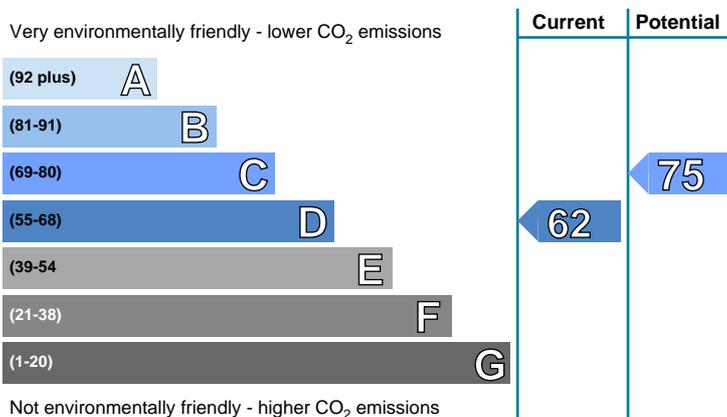
Environmental Impact (CO₂) Rating

This graph shows the effect of your home on the environment in terms of carbon dioxide (CO₂) emissions. The higher the rating, the less impact it has on the environment.
