Home Report

Scottish Single Survey

Property address	3 The Hollows Ayr Road Giffnock Glasgow G46 7JB
-------------------------	---

Prepared by	Shepherd Chartered Surveyors
--------------------	------------------------------

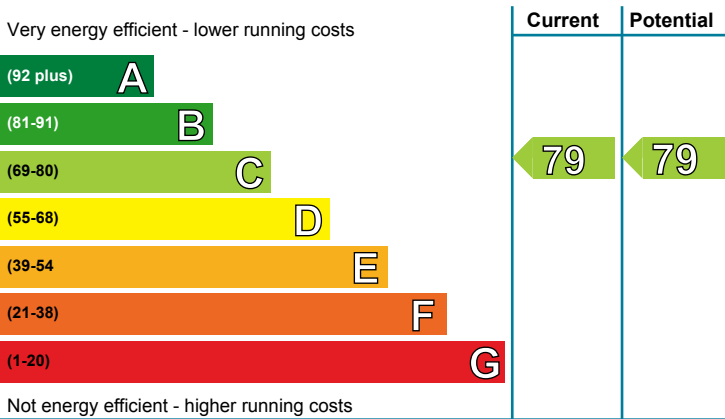
Energy Efficiency Rating

This graph shows the current efficiency of your home, taking into account both energy efficiency and fuel costs. The higher this rating, the lower your fuel bills are likely to be.

Your current rating is **band C (79)**. The average rating for EPCs in Scotland is **band D (61)**.

The potential rating shows the effect of undertaking all of the improvement measures listed within your recommendations report.
