19 TANTALLON TOWER  
5 DIRLETON DRIVE  
GLASGOW  
G41 3BE

# Home Report

FLAT 19 TANTALLON TOWER, 5 DIRLETON DRIVE, GLASGOW, G41 3BE

# Scottish Single Survey

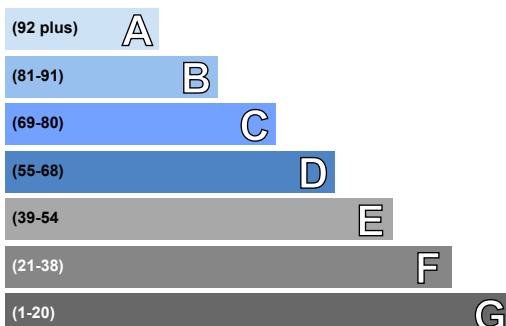
Current	Potential
49	53
