51 CARLIBAR ROAD
BARRHEAD
GLASGOW
G78 1AD

Home Report

Energy Performance Certificate

Scottish Single Survey

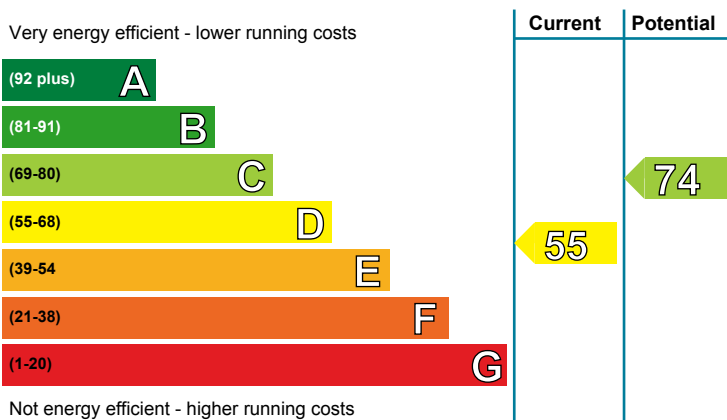
Energy Efficiency Rating

This graph shows the current efficiency of your home, taking into account both energy efficiency and fuel costs. The higher this rating, the lower your fuel bills are likely to be.

Your current rating is **band D (55)**. The average rating for EPCs in Scotland is **band D (61)**.

The potential rating shows the effect of undertaking all of the improvement measures listed within your recommendations report.

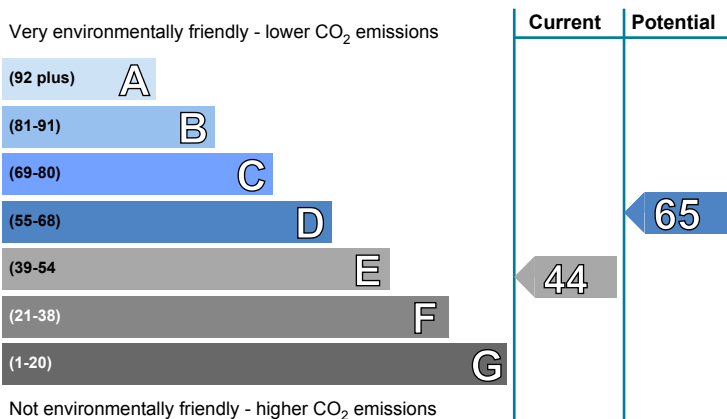
Environmental Impact (CO₂) Rating

This graph shows the effect of your home on the environment in terms of carbon dioxide (CO₂) emissions. The higher the rating, the less impact it has on the environment.

Your current rating is **band E (44)**. The average rating for EPCs in Scotland is **band D (59)**.

The potential rating shows the effect of undertaking all of the improvement measures listed within your recommendations report.
