29 BALLANTINE DRIVE

# Home Report

29 BALLANTINE DRIVE, AYR, KA7 2RG

# Scottish Single Survey

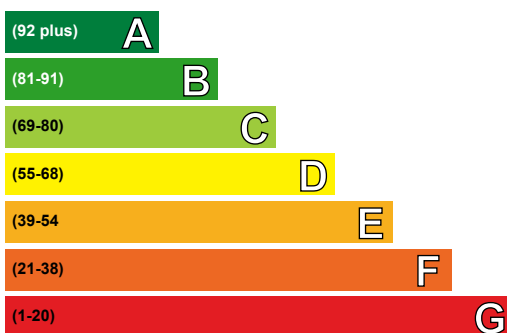
## Energy Efficiency Rating

This graph shows the current efficiency of your home, taking into account both energy efficiency and fuel costs. The higher this rating, the lower your fuel bills are likely to be.

Your current rating is **band D (55)**. The average rating for EPCs in Scotland is **band D (61)**.

The potential rating shows the effect of undertaking all of the improvement measures listed within your recommendations report.

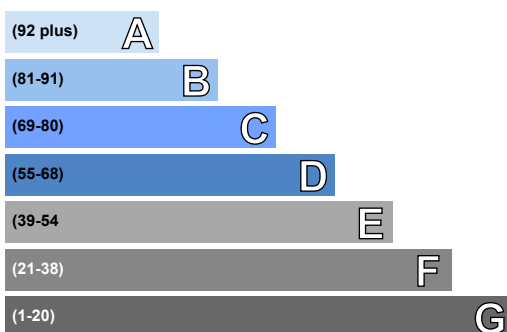
Very environmentally friendly - lower CO<sub>2</sub> emissions

Not environmentally friendly - higher CO<sub>2</sub> emissions

The potential rating shows the effect of undertaking all of the improvement measures listed within your recommendations report.

The average Scottish household produces about 6 tonnes of carbon dioxide every year. Based on this assessment, heating and lighting this home currently produces approximately 22 tonnes of carbon dioxide every year. Adopting recommendations in this report can reduce emissions and protect the environment. If you were to install all of these recommendations this could reduce emissions by 12.9 tonnes per year. You could reduce emissions even more by switching to renewable energy sources.
