11 PORTENCROSS ROAD  
WEST KILBRIDE  
KA23 9ES

# Home Report

# Energy Performance Certificate

# Scottish Single Survey

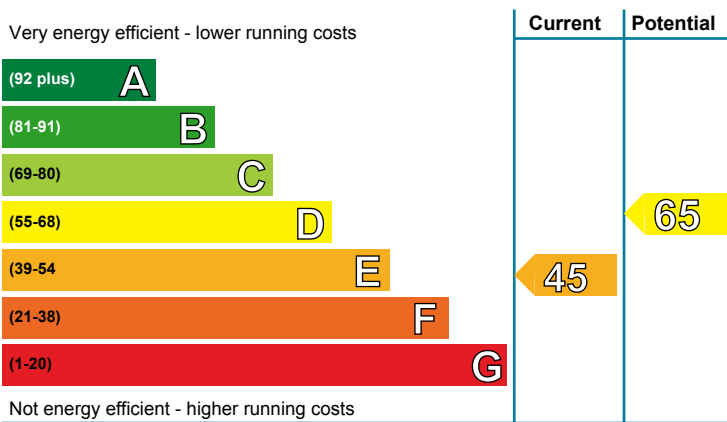
## Energy Efficiency Rating

This graph shows the current efficiency of your home, taking into account both energy efficiency and fuel costs. The higher this rating, the lower your fuel bills are likely to be.

Your current rating is **band E (45)**. The average rating for EPCs in Scotland is **band D (61)**.

The potential rating shows the effect of undertaking all of the improvement measures listed within your recommendations report.

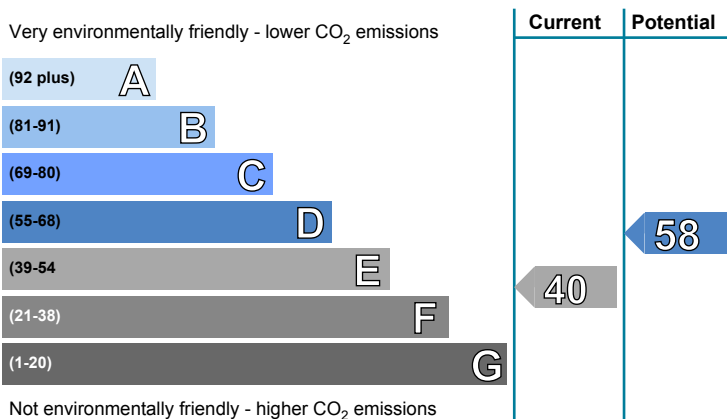
## Environmental Impact (CO<sub>2</sub>) Rating

This graph shows the effect of your home on the environment in terms of carbon dioxide (CO<sub>2</sub>) emissions. The higher the rating, the less impact it has on the environment.

Your current rating is **band E (40)**. The average rating for EPCs in Scotland is **band D (59)**.

The potential rating shows the effect of undertaking all of the improvement measures listed within your recommendations report.
