36 CHALMERS AVENUE

# Home Report

36 CHALMERS AVENUE, AYR, KA7 2NG

# Scottish Single Survey

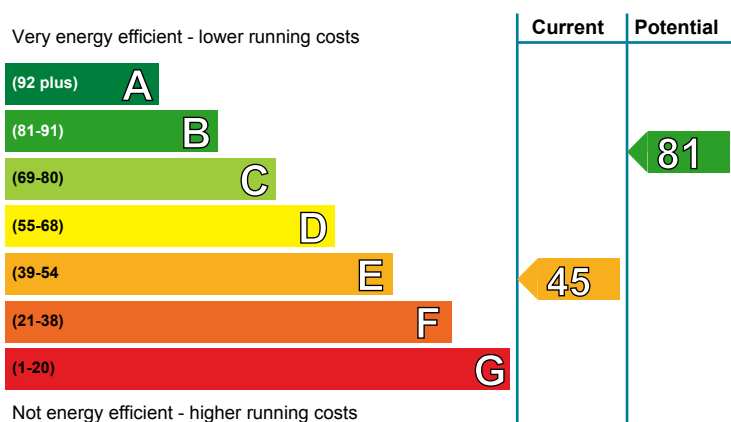
## Energy Efficiency Rating

This graph shows the current efficiency of your home, taking into account both energy efficiency and fuel costs. The higher this rating, the lower your fuel bills are likely to be.

Your current rating is **band E (45)**. The average rating for EPCs in Scotland is **band D (61)**.

The potential rating shows the effect of undertaking all of the improvement measures listed within your recommendations report.

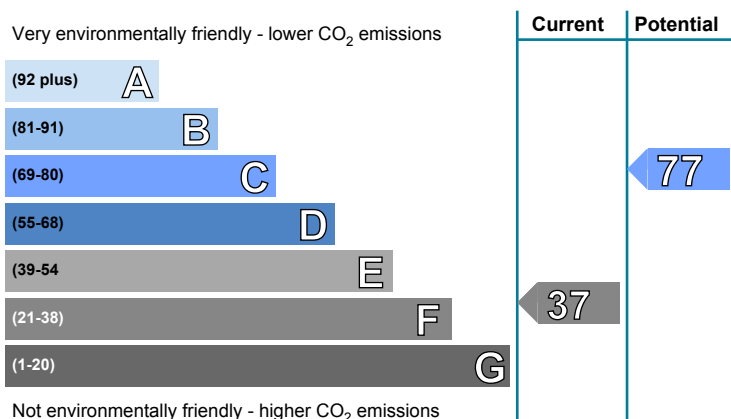
## Environmental Impact (CO<sub>2</sub>) Rating

This graph shows the effect of your home on the environment in terms of carbon dioxide (CO<sub>2</sub>) emissions. The higher the rating, the less impact it has on the environment.

The potential rating shows the effect of undertaking all of the improvement measures listed within your recommendations report.
