1 CAVENDISH PLACE

# Home Report

1 CAVENDISH PLACE, TROON, KA10 6JG

# Scottish Single Survey

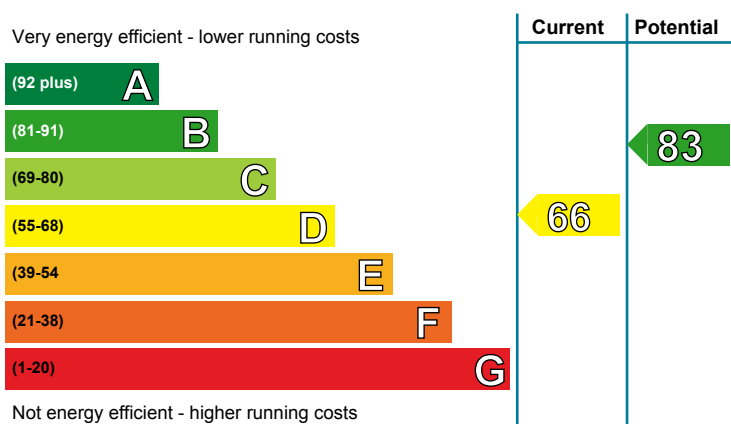
## Energy Efficiency Rating

This graph shows the current efficiency of your home, taking into account both energy efficiency and fuel costs. The higher this rating, the lower your fuel bills are likely to be.

Your current rating is **band D (66)**. The average rating for EPCs in Scotland is **band D (61)**.

The potential rating shows the effect of undertaking all of the improvement measures listed within your recommendations report.

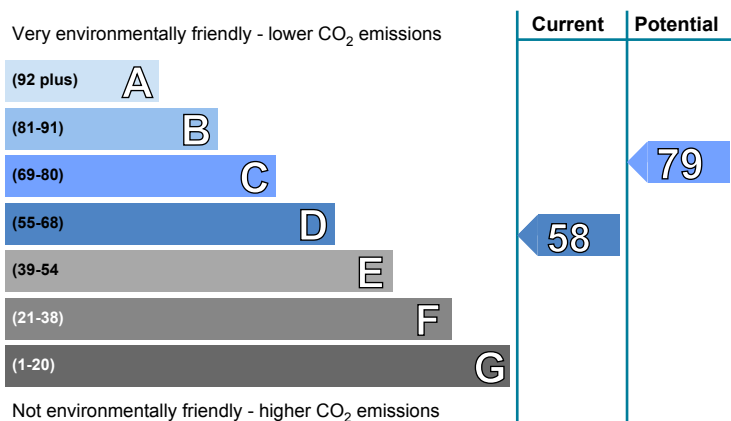
## Environmental Impact (CO<sub>2</sub>) Rating

This graph shows the effect of your home on the environment in terms of carbon dioxide (CO<sub>2</sub>) emissions. The higher the rating, the less impact it has on the environment.

The potential rating shows the effect of undertaking all of the improvement measures listed within your recommendations report.
