63 PRESTWICK ROAD

# Home Report

# Energy Performance Certificate (EPC)

# Scottish Single Survey

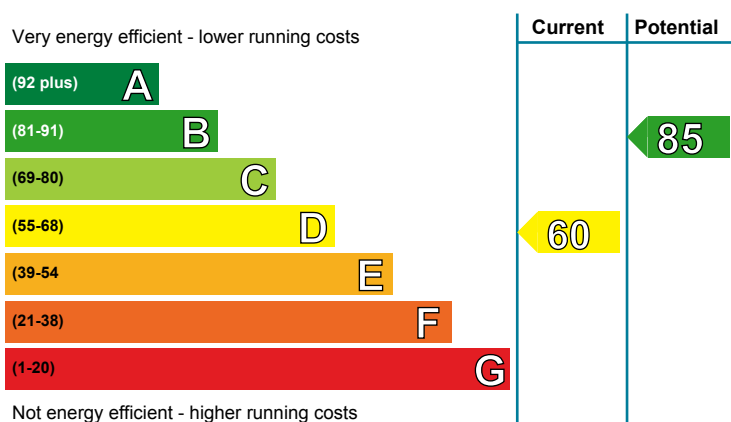
## Energy Efficiency Rating

This graph shows the current efficiency of your home, taking into account both energy efficiency and fuel costs. The higher this rating, the lower your fuel bills are likely to be.

Your current rating is **band D (60)**. The average rating for EPCs in Scotland is **band D (61)**.

The potential rating shows the effect of undertaking all of the improvement measures listed within your recommendations report.
