6 SOUTHPARK ROAD

# Home Report

# Energy Performance Certificate (EPC)

# Scottish Single Survey

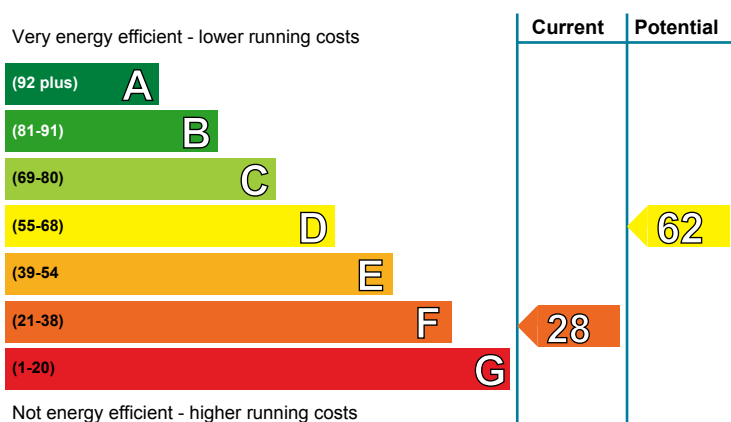
## Energy Efficiency Rating

This graph shows the current efficiency of your home, taking into account both energy efficiency and fuel costs. The higher this rating, the lower your fuel bills are likely to be.

Your current rating is **band F (28)**. The average rating for EPCs in Scotland is **band D (61)**.

The potential rating shows the effect of undertaking all of the improvement measures listed within your recommendations report.

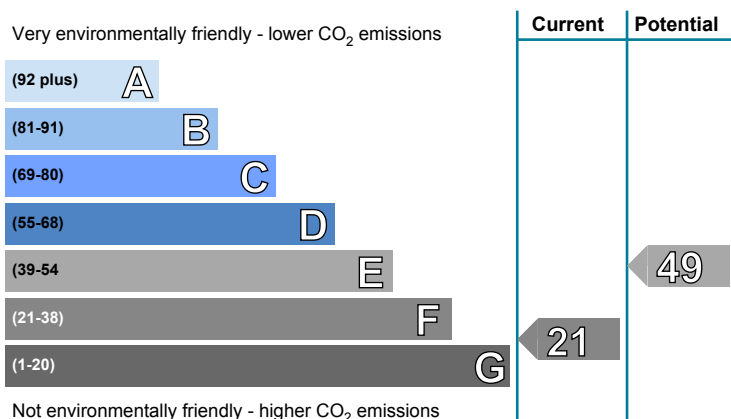
## Environmental Impact (CO<sub>2</sub>) Rating

This graph shows the effect of your home on the environment in terms of carbon dioxide (CO<sub>2</sub>) emissions. The higher the rating, the less impact it has on the environment.

The potential rating shows the effect of undertaking all of the improvement measures listed within your recommendations report.
