FLAT 0/1  
13 ST JOHNS ROAD  
GLASGOW  
G41 5QP

# Home Report

# Energy Performance Certificate

FLAT 0/1 , 13 ST JOHNS ROAD, GLASGOW, G41 5QP

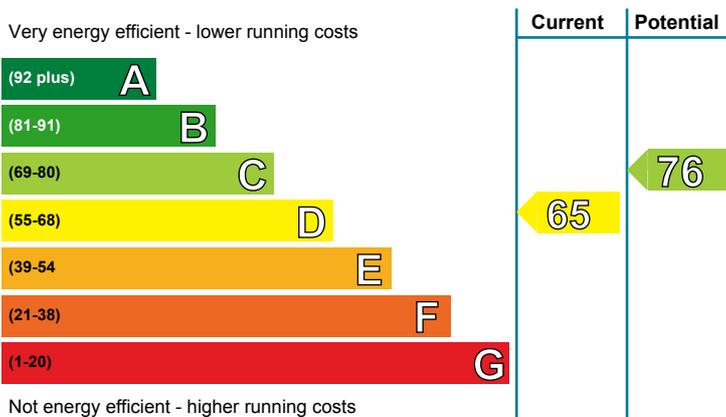
## Energy Efficiency Rating

This graph shows the current efficiency of your home, taking into account both energy efficiency and fuel costs. The higher this rating, the lower your fuel bills are likely to be.

Your current rating is **band D (65)**. The average rating for EPCs in Scotland is **band D (61)**.

The potential rating shows the effect of undertaking all of the improvement measures listed within your recommendations report.

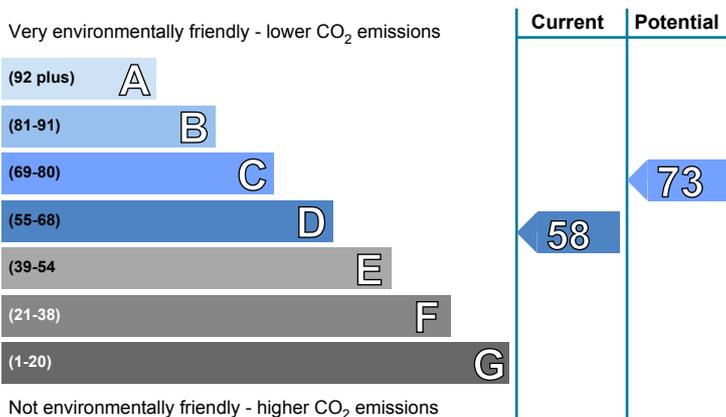
## Environmental Impact (CO<sub>2</sub>) Rating

This graph shows the effect of your home on the environment in terms of carbon dioxide (CO<sub>2</sub>) emissions. The higher the rating, the less impact it has on the environment.

Your current rating is **band D (58)**. The average rating for EPCs in Scotland is **band D (59)**.

The potential rating shows the effect of undertaking all of the improvement measures listed within your recommendations report.
