21 HOMESHAW HOUSE
27 BROOMHILL GARDENS
NEWTON MEARNS
GLASGOW
G77 5HP

Home Report

FLAT 21 HOMESHAU HOUSE, 27 BROOMHILL GARDENS, NEWTON MEARNS, GLASGOW, G77 5HP

Scottish Single Survey

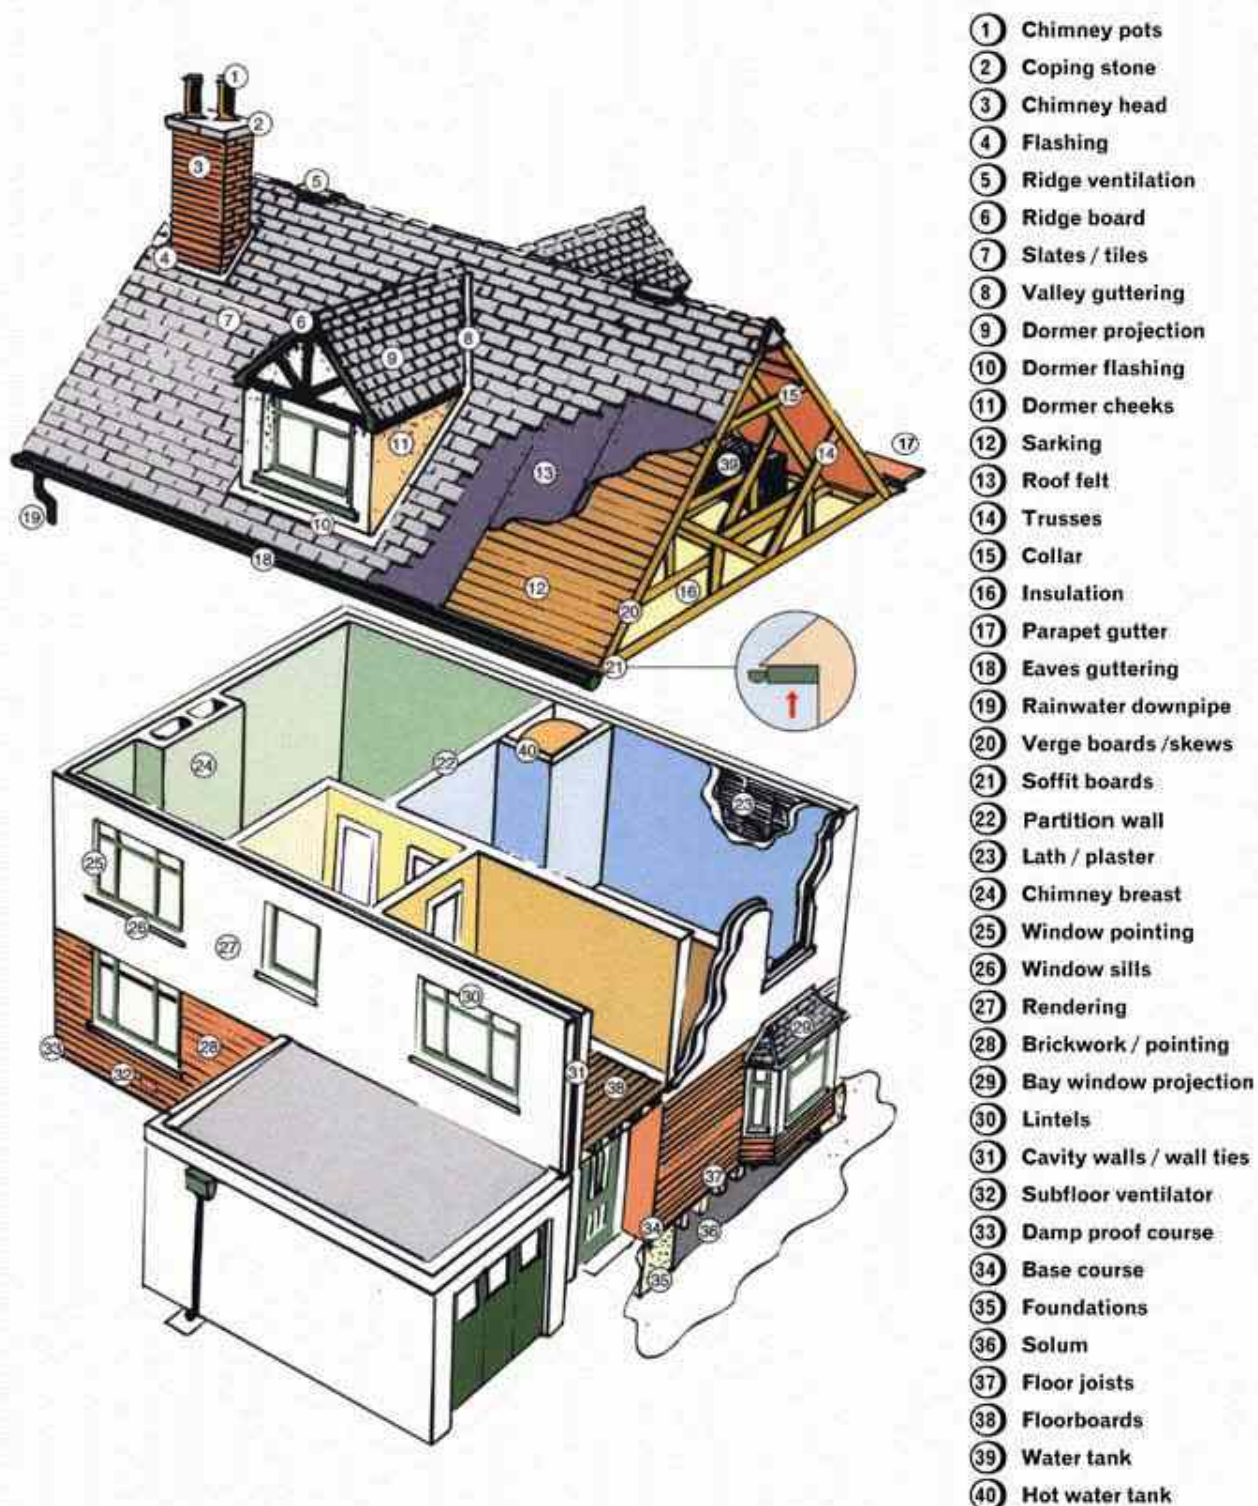
Sectional Diagram showing elements of a typical house

Reference may be made in this report to some or all of the above component parts of the property. This diagram may assist you in locating and understanding these items.
