Home Report

Energy Performance Certificate

17 LUGAR PLACE, TROON, KA10 7EA

Scottish Single Survey

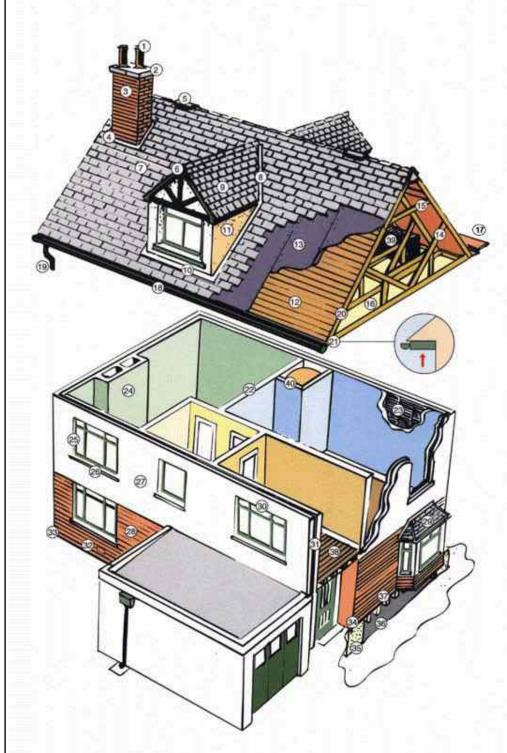
Sectional Diagram showing elements of a typical house

Reference may be made in this report to some or all of the above component parts of the property. This diagram may assist you in locating and understanding these items.

- 1) Chimney pots
- (2) Coping stone
- 3) Chimney head
- 4) Flashing
- 5) Ridge ventilation
- 6) Ridge board
- 7) Slates / tiles
- (8) Valley guttering
- 9) Dormer projection
- 10 Dormer flashing
- 11) Dormer cheeks
- 12) Sarking
- (13) Roof felt
- (14) Trusses
- 15) Collar
- (16) Insulation
- 17) Parapet gutter
- (18) Eaves guttering
- 19) Rainwater downpipe
- Verge boards /skews
- (21) Soffit boards
- (22) Partition wall
- 23 Lath / plaster
- 24) Chimney breast
- 25) Window pointing
- (6) Window sills
- (27) Rendering
- (28) Brickwork / pointing
- 29) Bay window projection
- (30) Lintels
- (31) Cavity walls / wall ties
- 32) Subfloor ventilator
- 33) Damp proof course
- 34) Base course
- 35) Foundations
- 36) Solum
- 37) Floor joists
- 38) Floorboards
 - Water tank
- 40) Hot water tank
