YOUR ONESURVEY HOME REPORT

10 Farrell Crescent Drongan, Ayr KA6 7EQ

SINGLE Survey

Single Survey

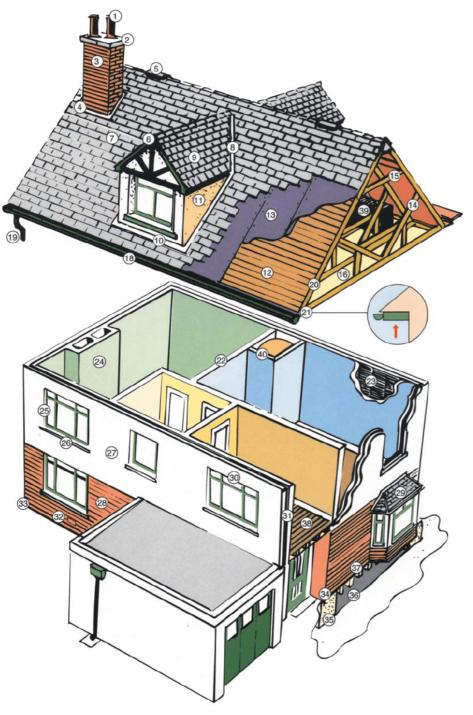
Sectional Diagram showing elements of a typical house

Reference may be made in this report to some or all of the above component parts of the property. This diagram may assist you in locating and understanding these items.

1	Chimney pots
	$\check{2}$	Coping stone
	3	Chimney head
	4	Flashing
	5	Ridge ventilation
	6	Ridge board
	$\overline{0}$	Slates / tiles
	8	Valley guttering
	9	Dormer projection
	10	Dormer flashing
	1	Dormer cheeks
	12	Sarking
•	13	Roof felt
	14	Trusses
	15	Collar
	16	Insulation
	17	Parapet gutter
	18	Eaves guttering
	19	Rainwater downpipe
	20	Verge boards /skews
	21	Soffit boards
	22	Partiton wall
	23	Lath / plaster
	24	Chimney breast
	25	Window pointing
	26	Window sills
	27	Rendering
	28	Brickwork / pointing
	29	Bay window projection
	30	Lintels
	31	Cavity walls / wall ties
	32	Subfloor ventilator
	33	Damp proof course
	34	Base course
	35	Foundations
	36	Solum
	37	Floor joists
	38	Floorboards
	39	Water tank
	40	Hot water tank
