YOUR ONESURVEY HOME REPORT

38 Lansdowne Crescent Glasgow G20 6NH

Single Survey

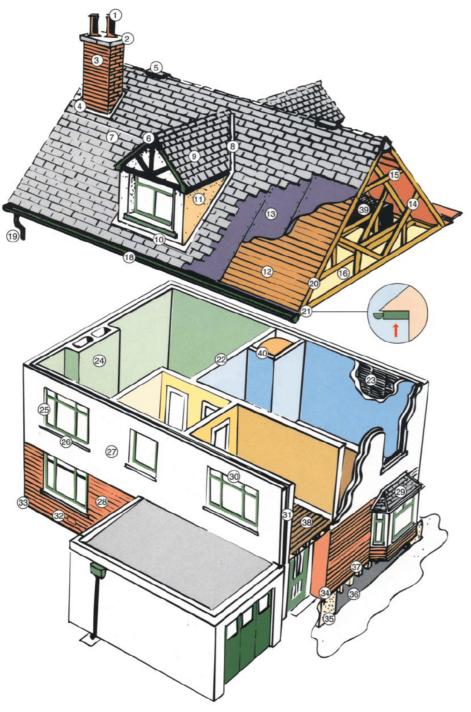
Sectional Diagram showing elements of a typical house

Reference may be made in this report to some or all of the above component parts of the property. This diagram may assist you in locating and understanding these items.

1	Chimney pots
	2	Coping stone
	3	Chimney head
	4	Flashing
	5	Ridge ventilation
	6	Ridge board
	\bigcirc	Slates / tiles
	8	Valley guttering
	9	Dormer projection
	10	Dormer flashing
	11	Dormer cheeks
	12	Sarking
>	13	Roof felt
	14	Trusses
	15	Collar
	16	Insulation
	17	Parapet gutter
	18	Eaves guttering
	19	Rainwater downpipe
	20	Verge boards /skews
	21	Soffit boards
	22	Partiton wall
	23	Lath / plaster
	24	Chimney breast
	25	Window pointing
	26	Window sills
	27	Rendering
	28	Brickwork / pointing
	29	Bay window projection
	30	Lintels
		Cavity walls / wall ties
	32	Subfloor ventilator
	33	Damp proof course
	34	Base course
	35	Foundations
	36	Solum
	37	Floor joists
	38	Floorboards
	39	Water tank
	40	Hot water tank
