YOUR ONESURVEY
HOME REPORT

4 Whittingehame Gardens
1095 Great Western Road
Glasgow
G12 0AA

HOME REPORT

SINGLE SURVEY

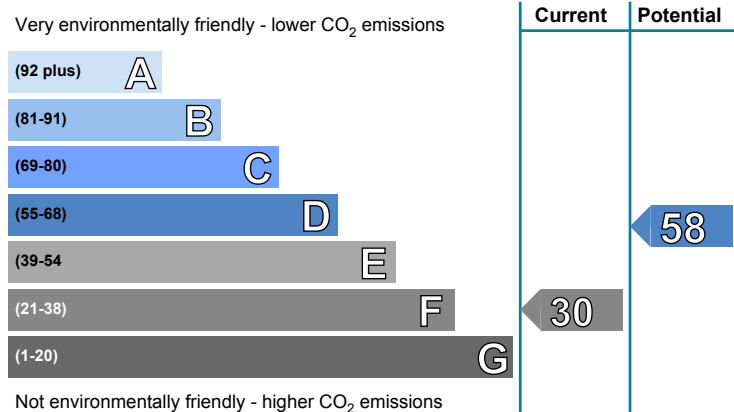
* based upon the cost of energy for heating, hot water, lighting and ventilation, calculated using standard assumptions

The potential rating shows the effect of undertaking all of the improvement measures listed within your recommendations report.
