YOUR ONESURVEY  
**HOME REPORT**

Flat 0/2  
7 Winton Drive  
Glasgow  
G12 0PZ

# SINGLE SURVEY

A report on the condition of the property, with categories  
being rated from 1 to 3.

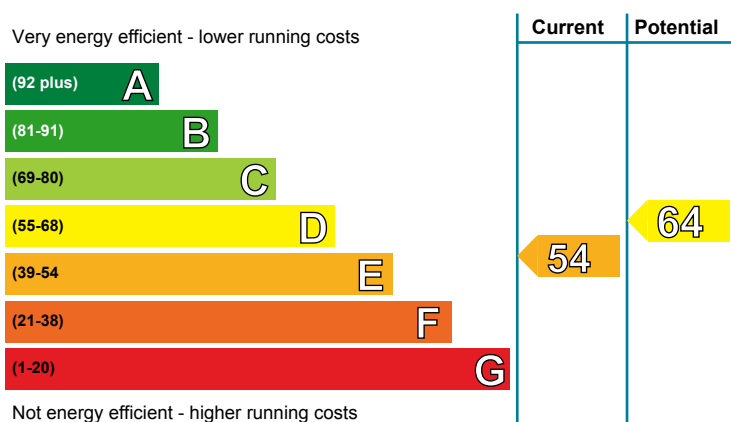
## Energy Efficiency Rating

This graph shows the current efficiency of your home, taking into account both energy efficiency and fuel costs. The higher this rating, the lower your fuel bills are likely to be.

Your current rating is **band E (54)**. The average rating for EPCs in Scotland is **band D (61)**.

The potential rating shows the effect of undertaking all of the improvement measures listed within your recommendations report.

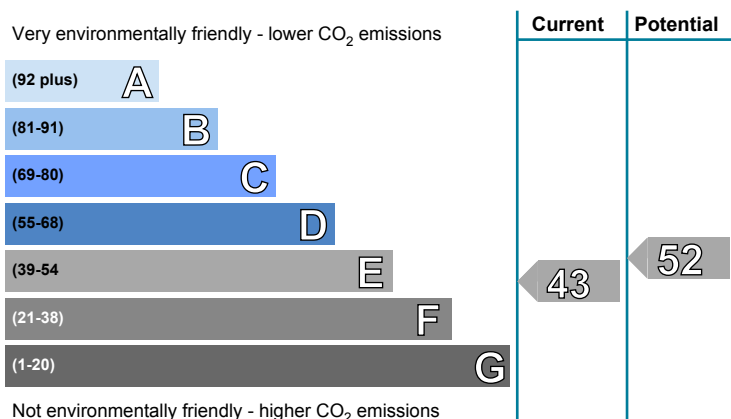
## Environmental Impact (CO<sub>2</sub>) Rating

This graph shows the effect of your home on the environment in terms of carbon dioxide (CO<sub>2</sub>) emissions. The higher the rating, the less impact it has on the environment.
