HOME REPORT

5 BARR CRESCENT
LARGS
KA30 8PX

Energy Performance Certificate (EPC)

5 BARR CRESCENT, LARGS, KA30 8PX

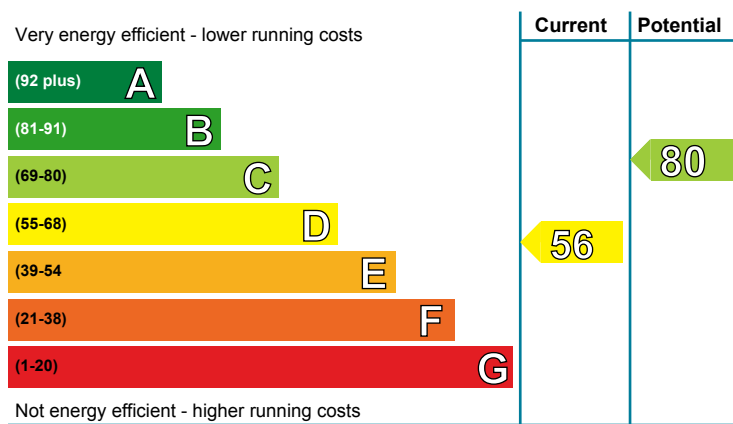
Energy Efficiency Rating

This graph shows the current efficiency of your home, taking into account both energy efficiency and fuel costs. The higher this rating, the lower your fuel bills are likely to be.

Your current rating is **band D (56)**. The average rating for EPCs in Scotland is **band D (61)**.

The potential rating shows the effect of undertaking all of the improvement measures listed within your recommendations report.

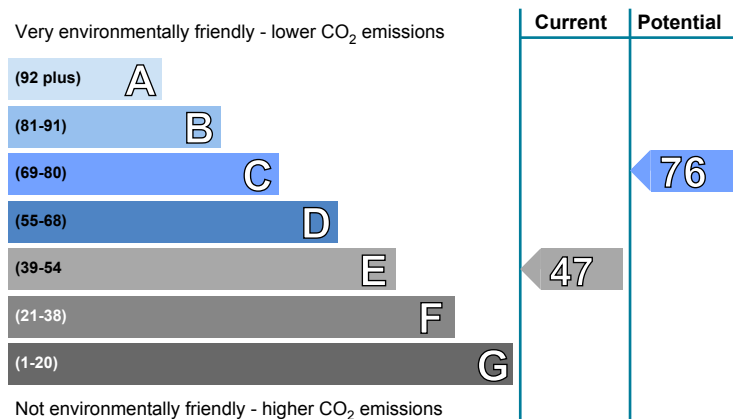
Environmental Impact (CO₂) Rating

This graph shows the effect of your home on the environment in terms of carbon dioxide (CO₂) emissions. The higher the rating, the less impact it has on the environment.

Your current rating is **band E (47)**. The average rating for EPCs in Scotland is **band D (59)**.

The potential rating shows the effect of undertaking all of the improvement measures listed within your recommendations report.
