84 SOUTH BEACH

Home Report

Scottish Single Survey

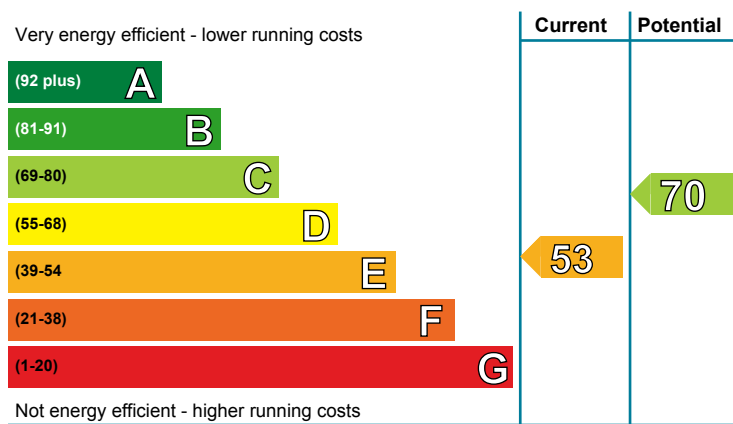
Energy Efficiency Rating

This graph shows the current efficiency of your home, taking into account both energy efficiency and fuel costs. The higher this rating, the lower your fuel bills are likely to be.

Your current rating is **band E (53)**. The average rating for EPCs in Scotland is **band D (61)**.

The potential rating shows the effect of undertaking all of the improvement measures listed within your recommendations report.

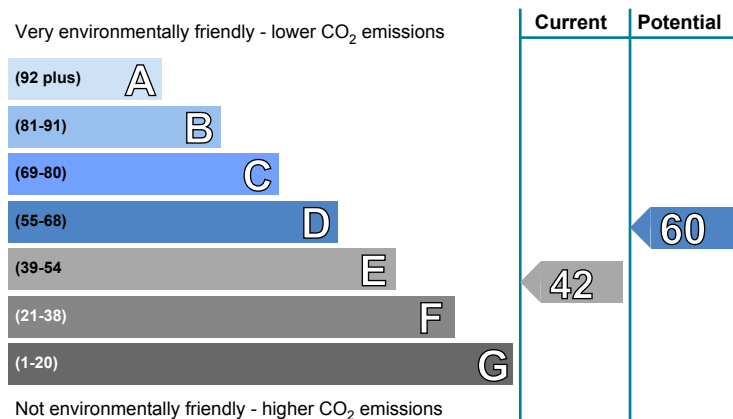
Environmental Impact (CO₂) Rating

This graph shows the effect of your home on the environment in terms of carbon dioxide (CO₂) emissions. The higher the rating, the less impact it has on the environment.

Your current rating is **band E (42)**. The average rating for EPCs in Scotland is **band D (59)**.

The potential rating shows the effect of undertaking all of the improvement measures listed within your recommendations report.
