YOUR ONESURVEY  
**HOME REPORT**

Flat 0/7  
354 Meadowside Quay Walk  
Glasgow  
G11 6ED

# SINGLE SURVEY

A report on the condition of the property, with categories  
being rated from 1 to 3.

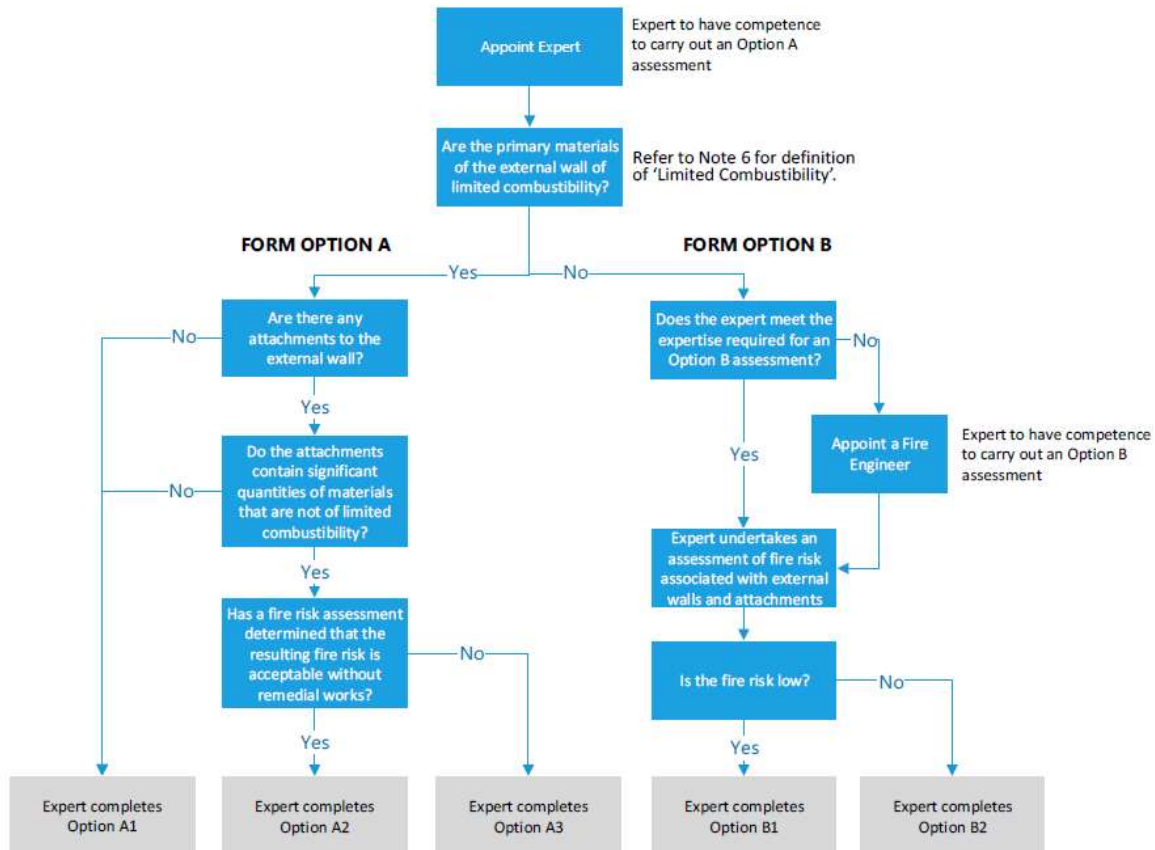
### Flow Chart

**Objective** - This form is intended for recording in a consistent manner what assessment has been carried out for the external wall construction of residential apartment buildings where the highest floor is 18m or more above ground level or where specific concerns exist <sup>(Note 1)</sup>. It should not be used for other purposes. It is to be completed by a competent person with the levels of expertise as described in Notes 2 and 3 below.
