YOUR ONESURVEY
HOME REPORT

Flat 2, 9 Doune Gardens
Glasgow
G20 6DJ

SINGLE SURVEY

A report on the condition of the property, with categories being rated from 1 to 3.

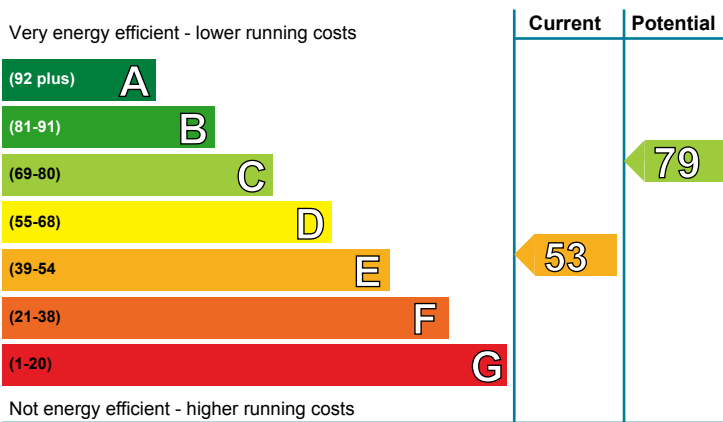
Energy Efficiency Rating

This graph shows the current efficiency of your home, taking into account both energy efficiency and fuel costs. The higher this rating, the lower your fuel bills are likely to be.

Your current rating is **band E (53)**. The average rating for EPCs in Scotland is **band D (61)**.

The potential rating shows the effect of undertaking all of the improvement measures listed within your recommendations report.

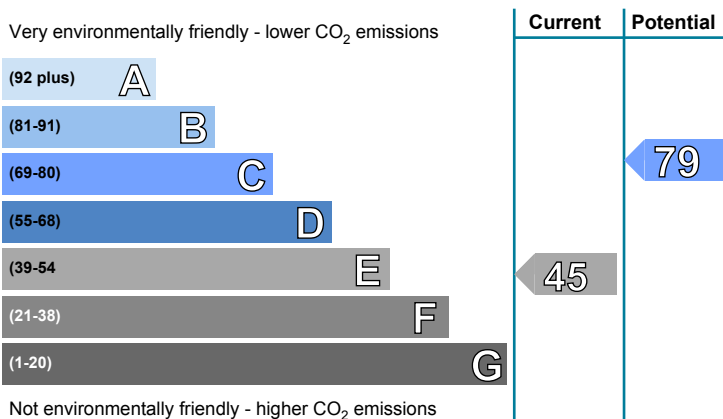
Environmental Impact (CO₂) Rating

This graph shows the effect of your home on the environment in terms of carbon dioxide (CO₂) emissions. The higher the rating, the less impact it has on the environment.
