YOUR ONESURVEY
HOME REPORT

12 Clairmont Gardens
Attic Flat
Glasgow
G3 7LW

SINGLE SURVEY

A report on the condition of the property, with categories being rated from 1 to 3.

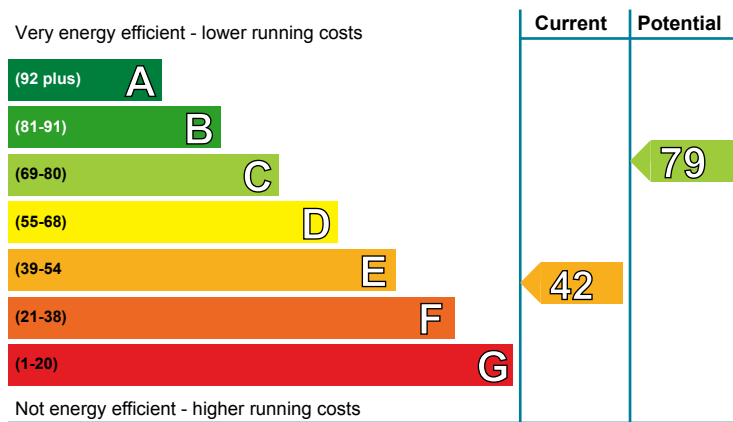
Energy Efficiency Rating

This graph shows the current efficiency of your home, taking into account both energy efficiency and fuel costs. The higher this rating, the lower your fuel bills are likely to be.

Your current rating is **band E (42)**. The average rating for EPCs in Scotland is **band D (61)**.

The potential rating shows the effect of undertaking all of the improvement measures listed within your recommendations report.

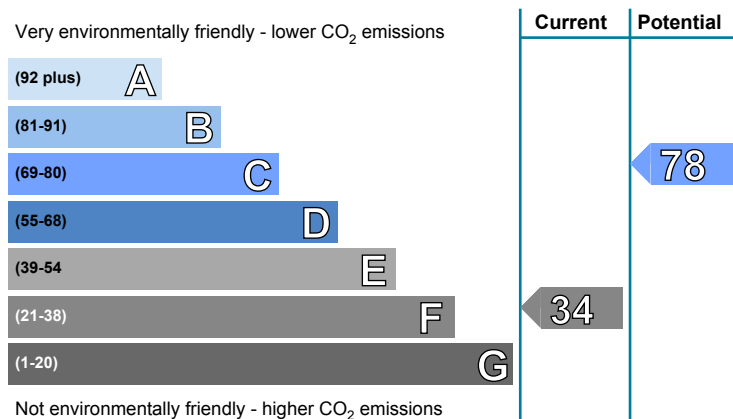
Environmental Impact (CO₂) Rating

This graph shows the effect of your home on the environment in terms of carbon dioxide (CO₂) emissions. The higher the rating, the less impact it has on the environment.
