FLAT D
18 MAIN STREET
LARGS
KA30 8AB

Home Report

FLAT D , 18 MAIN STREET, LARGS, KA30 8AB

Dwelling type: Mid-floor flat
Date of assessment: 04 February 2022
Date of certificate: 05 February 2022
Total floor area: 87 m²
Primary Energy Indicator: 158 kWh/m²/year

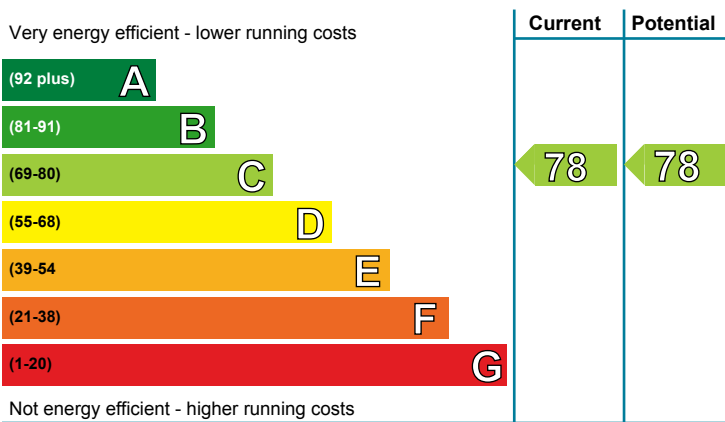
Energy Efficiency Rating

This graph shows the current efficiency of your home, taking into account both energy efficiency and fuel costs. The higher this rating, the lower your fuel bills are likely to be.

Your current rating is **band C (78)**. The average rating for EPCs in Scotland is **band D (61)**.

The potential rating shows the effect of undertaking all of the improvement measures listed within your recommendations report.

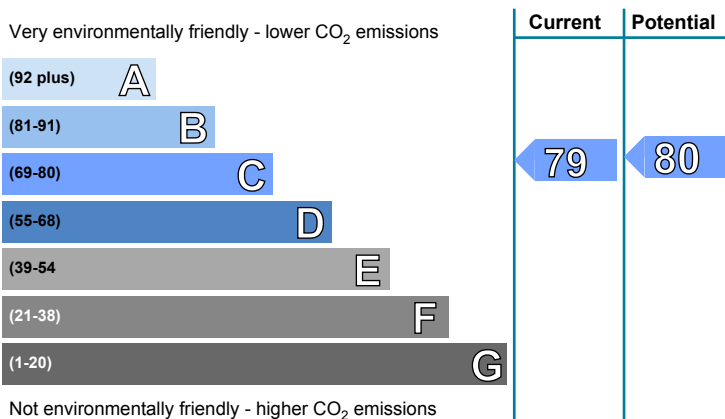
Environmental Impact (CO₂) Rating

This graph shows the effect of your home on the environment in terms of carbon dioxide (CO₂) emissions. The higher the rating, the less impact it has on the environment.

Your current rating is **band C (79)**. The average rating for EPCs in Scotland is **band D (59)**.

The potential rating shows the effect of undertaking all of the improvement measures listed within your recommendations report.
