# Home Report

# Single Survey

Property address	3/2 63 Dundrennan Road GLASGOW G42 9SA
------------------	-------------------------------------------------

Date of inspection	06/04/2022
--------------------	------------

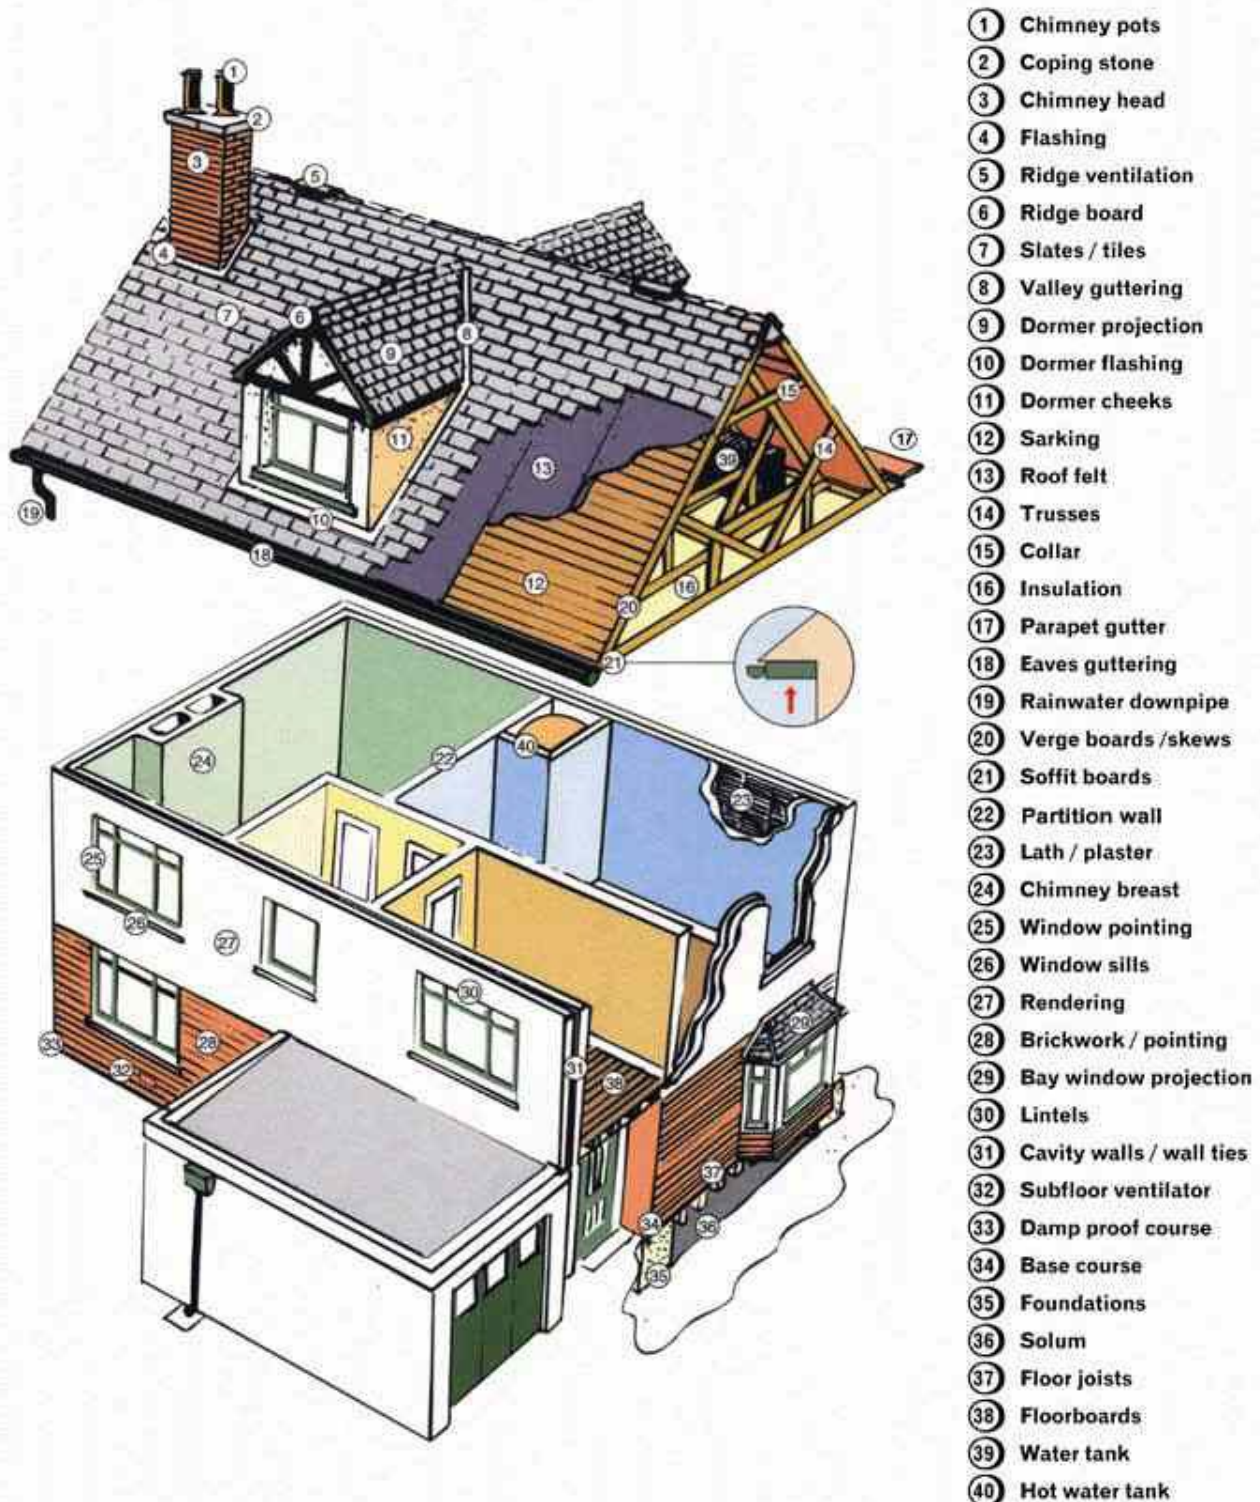
## Sectional Diagram showing elements of a typical house

Reference may be made in this report to some or all of the above component parts of the property. This diagram may assist you in locating and understanding these items.
