Home Report

Scottish Single Survey

Property address	38 Cumbrae Court Nelson Street LARGS KA30 8LG
-------------------------	--

Prepared by	J & E Shepherd
--------------------	----------------

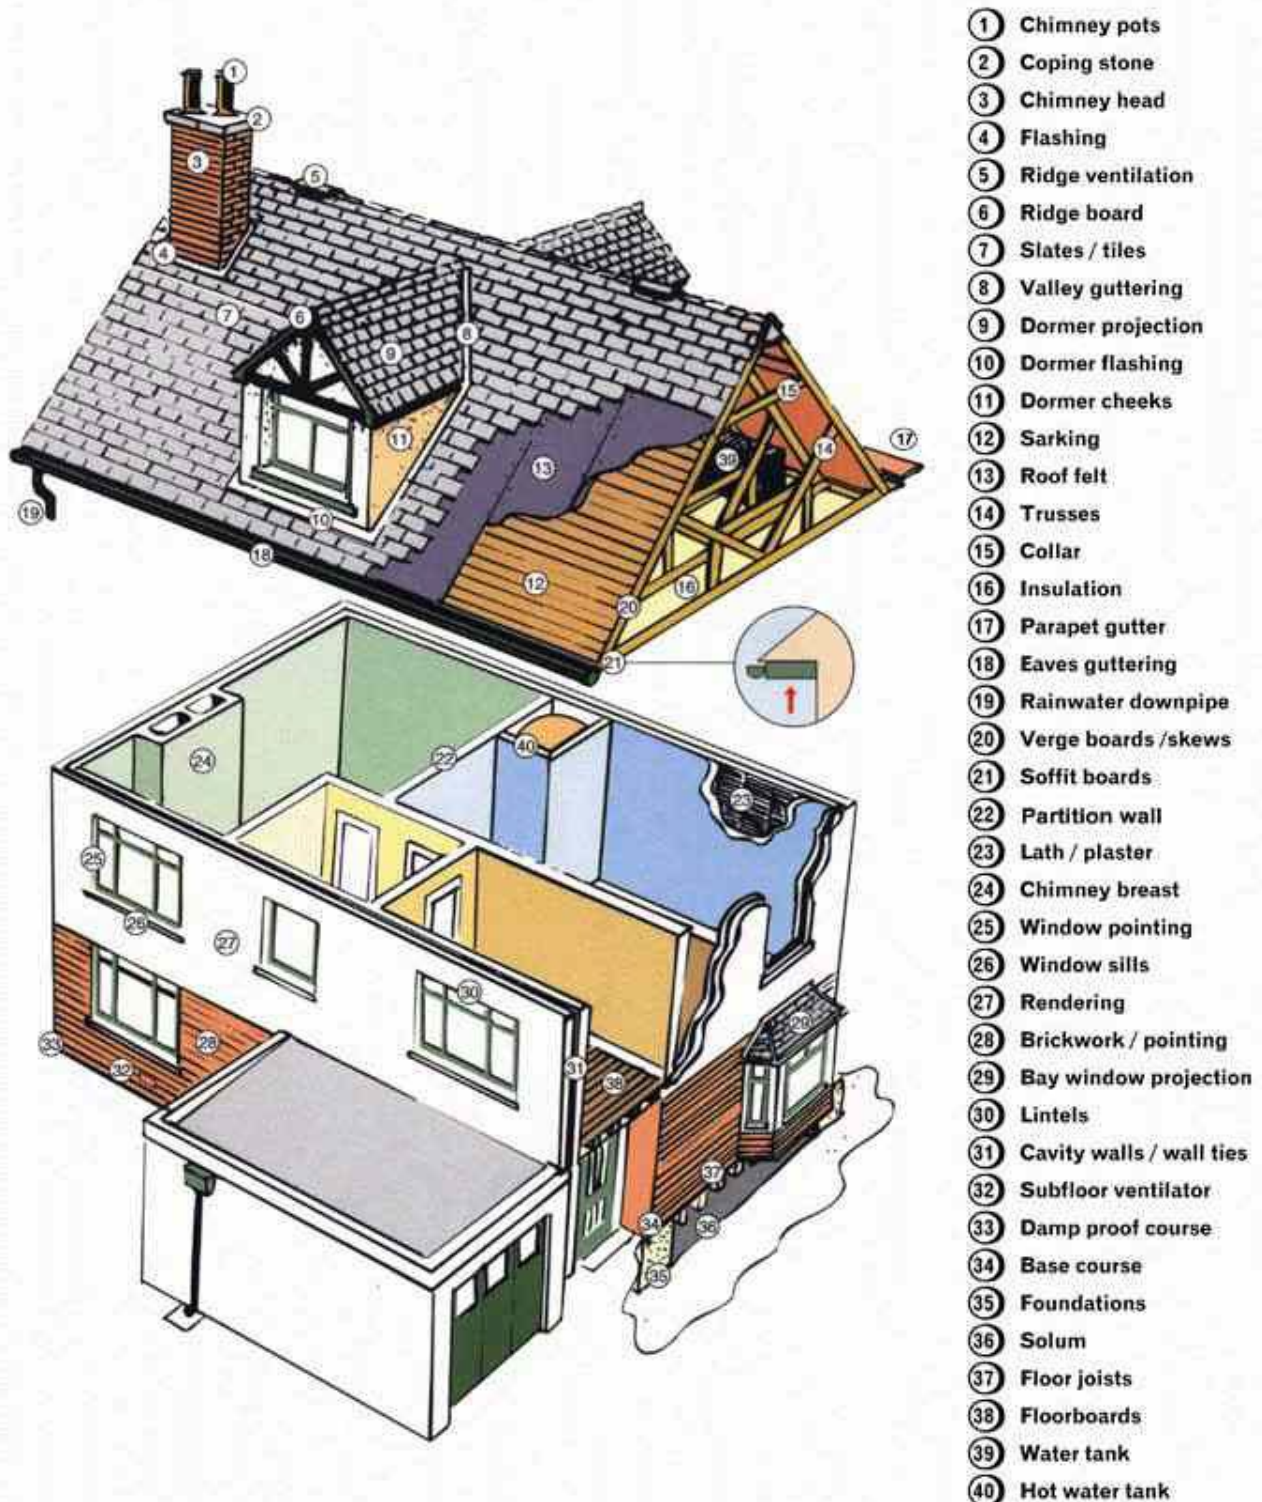
Sectional Diagram showing elements of a typical house

Reference may be made in this report to some or all of the above component parts of the property. This diagram may assist you in locating and understanding these items.

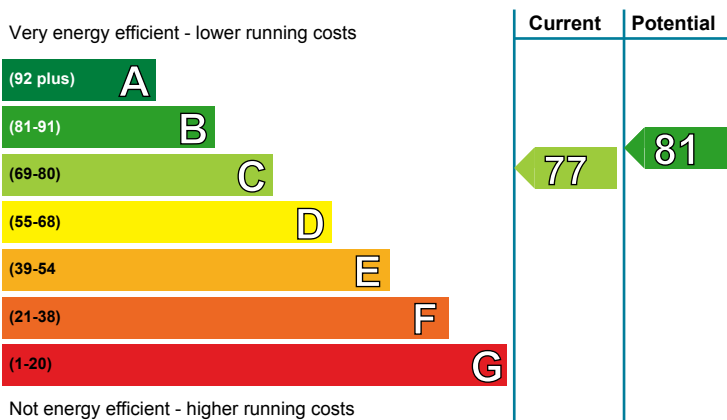
Energy Efficiency Rating

This graph shows the current efficiency of your home, taking into account both energy efficiency and fuel costs. The higher this rating, the lower your fuel bills are likely to be.

Your current rating is **band C (77)**. The average rating for EPCs in Scotland is **band D (61)**.

The potential rating shows the effect of undertaking all of the improvement measures listed within your recommendations report.

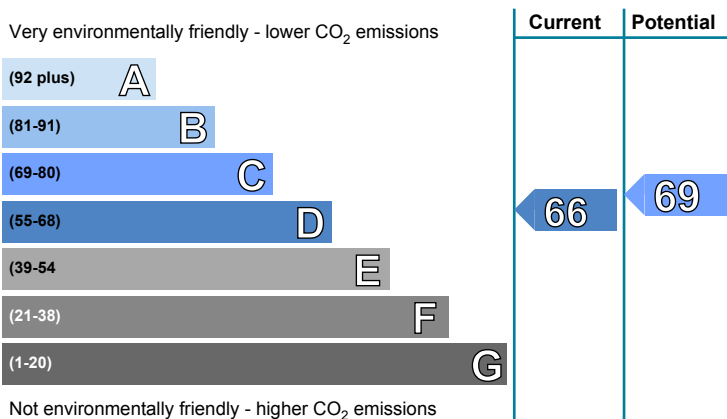
Environmental Impact (CO₂) Rating

This graph shows the effect of your home on the environment in terms of carbon dioxide (CO₂) emissions. The higher the rating, the less impact it has on the environment.
