BAYVIEW SHORE ROAD

Home Report

Energy Performance Certificate

Single Survey

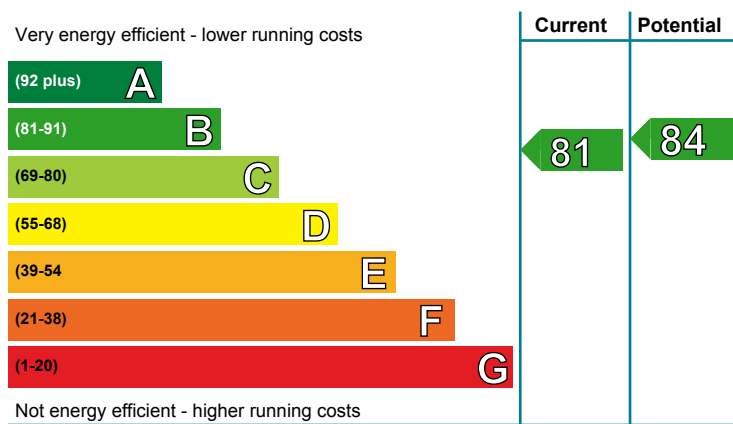
Energy Efficiency Rating

This graph shows the current efficiency of your home, taking into account both energy efficiency and fuel costs. The higher this rating, the lower your fuel bills are likely to be.

Your current rating is **band B (81)**. The average rating for EPCs in Scotland is **band D (61)**.

The potential rating shows the effect of undertaking all of the improvement measures listed within your recommendations report.

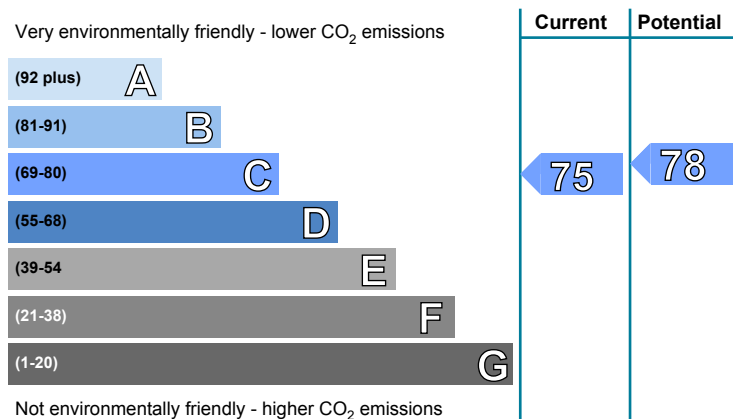
Environmental Impact (CO₂) Rating

This graph shows the effect of your home on the environment in terms of carbon dioxide (CO₂) emissions. The higher the rating, the less impact it has on the environment.

Your current rating is **band C (75)**. The average rating for EPCs in Scotland is **band D (59)**.

The potential rating shows the effect of undertaking all of the improvement measures listed within your recommendations report.
