Home Report

Single Survey

Property address	2 Sea Tower Gardens Bentfield Avenue AYR KA7 2XR
-------------------------	---

Date of inspection	11/04/2022
---------------------------	------------

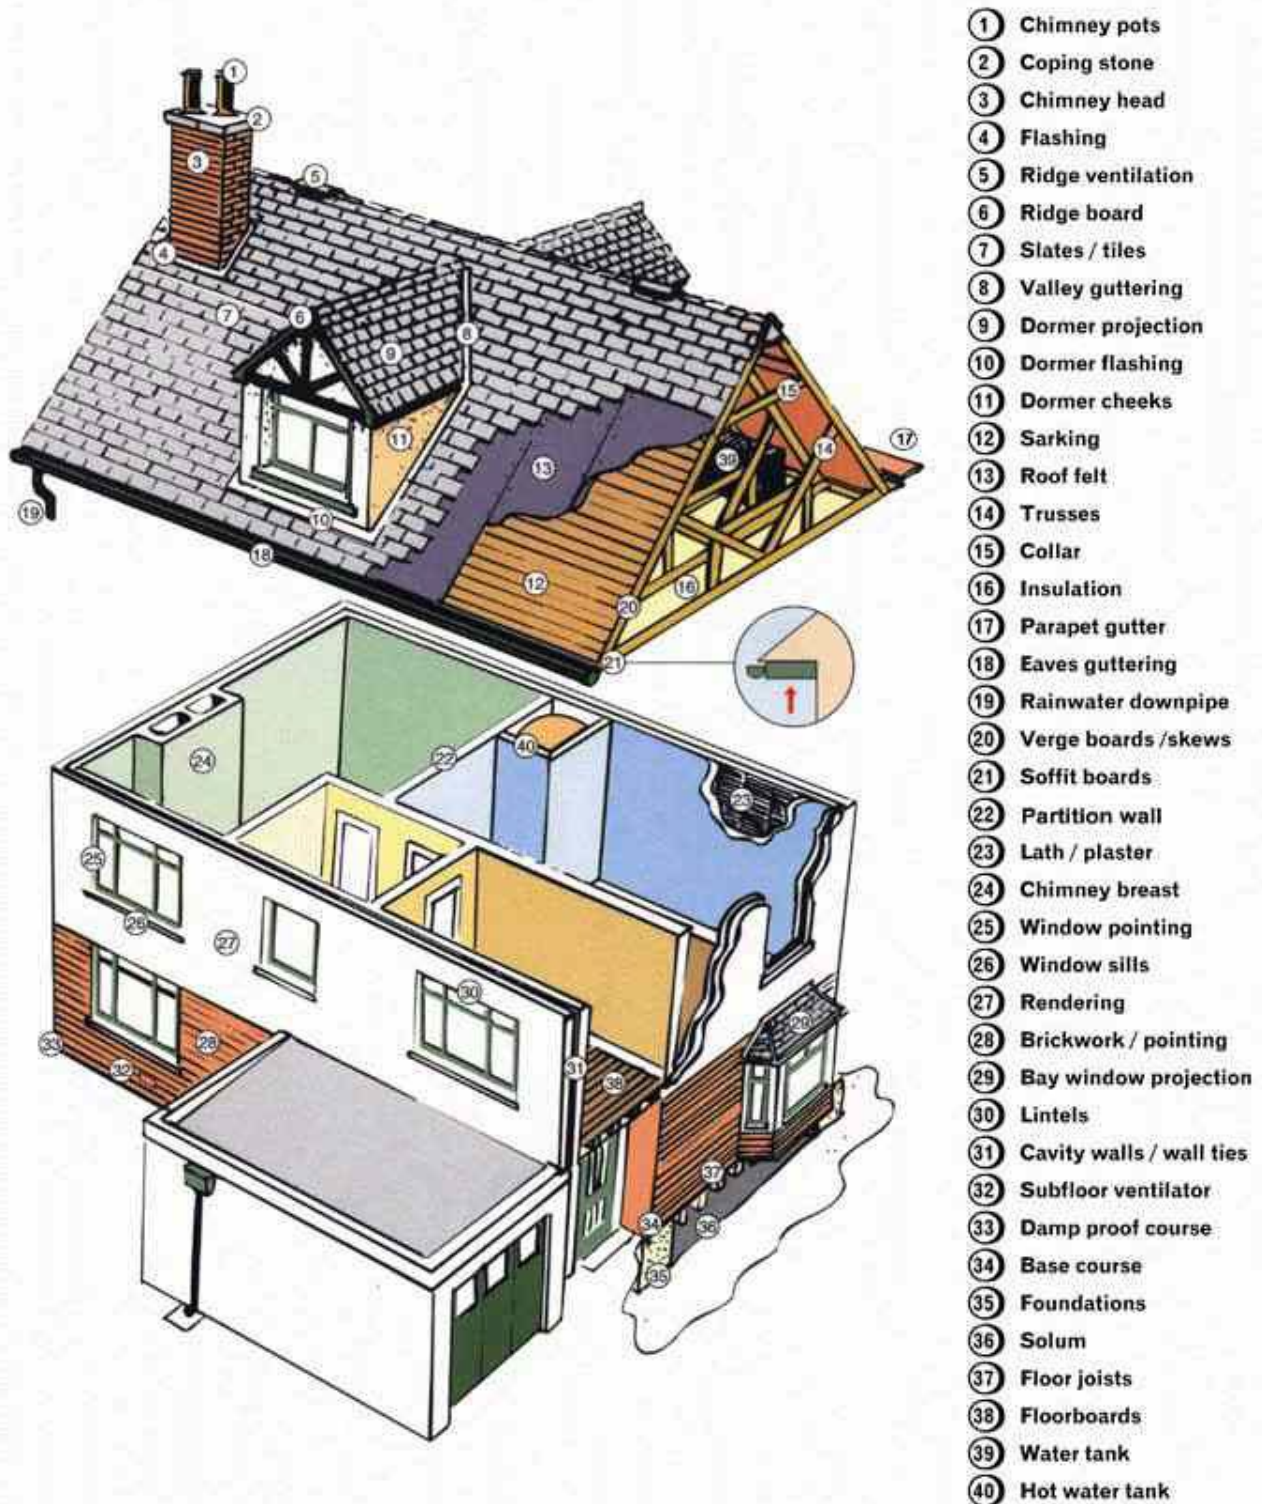
Sectional Diagram showing elements of a typical house

Reference may be made in this report to some or all of the above component parts of the property. This diagram may assist you in locating and understanding these items.

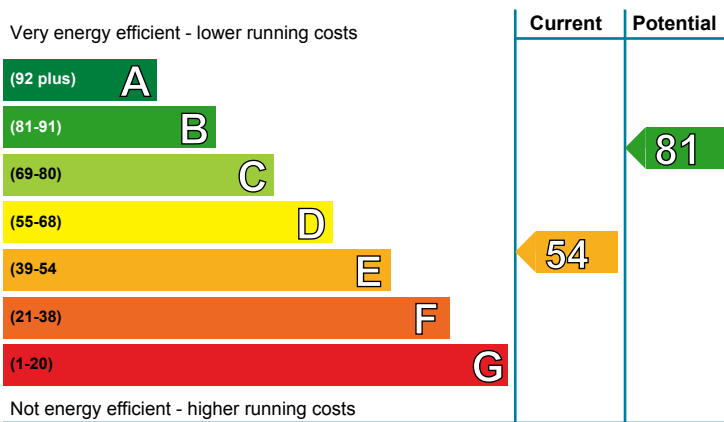
Energy Efficiency Rating

This graph shows the current efficiency of your home, taking into account both energy efficiency and fuel costs. The higher this rating, the lower your fuel bills are likely to be.

Your current rating is **band E (54)**. The average rating for EPCs in Scotland is **band D (61)**.

The potential rating shows the effect of undertaking all of the improvement measures listed within your recommendations report.

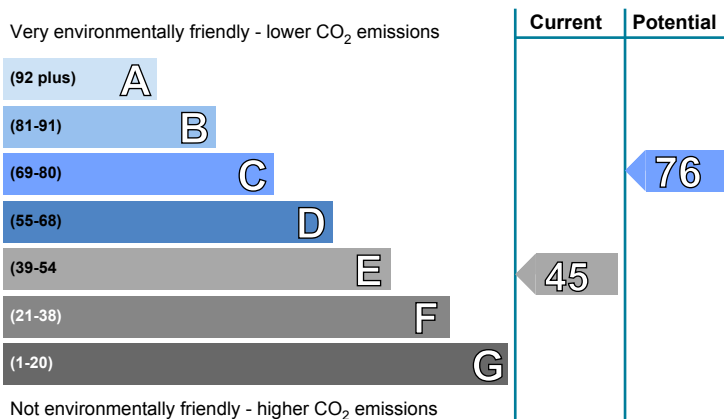
Environmental Impact (CO₂) Rating

This graph shows the effect of your home on the environment in terms of carbon dioxide (CO₂) emissions. The higher the rating, the less impact it has on the environment.
