19 DOONVALE PLACE

# Home Report

19 DOONVALE PLACE, AYR, KA6 6FD

# Single Survey

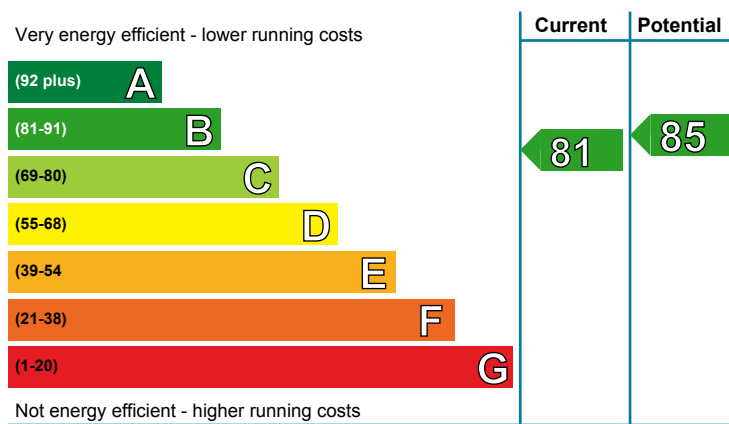
## Energy Efficiency Rating

This graph shows the current efficiency of your home, taking into account both energy efficiency and fuel costs. The higher this rating, the lower your fuel bills are likely to be.

Your current rating is **band B (81)**. The average rating for EPCs in Scotland is **band D (61)**.

The potential rating shows the effect of undertaking all of the improvement measures listed within your recommendations report.

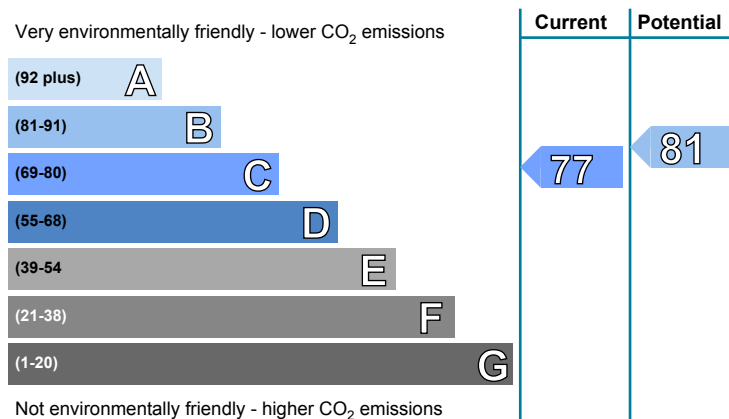
## Environmental Impact (CO<sub>2</sub>) Rating

This graph shows the effect of your home on the environment in terms of carbon dioxide (CO<sub>2</sub>) emissions. The higher the rating, the less impact it has on the environment.

Your current rating is **band C (77)**. The average rating for EPCs in Scotland is **band D (59)**.

The potential rating shows the effect of undertaking all of the improvement measures listed within your recommendations report.
