Home Report

Scottish Single Survey

Property address	Flat 1 Aubery Court 6 Aubery Crescent LARGS KA30 8PR
-------------------------	--

Prepared by	J & E Shepherd Chartered Surveyors
--------------------	------------------------------------

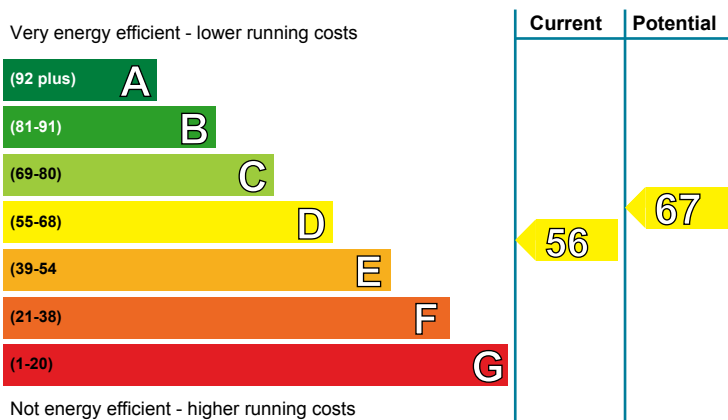
Energy Efficiency Rating

This graph shows the current efficiency of your home, taking into account both energy efficiency and fuel costs. The higher this rating, the lower your fuel bills are likely to be.

Your current rating is **band D (56)**. The average rating for EPCs in Scotland is **band D (61)**.

The potential rating shows the effect of undertaking all of the improvement measures listed within your recommendations report.

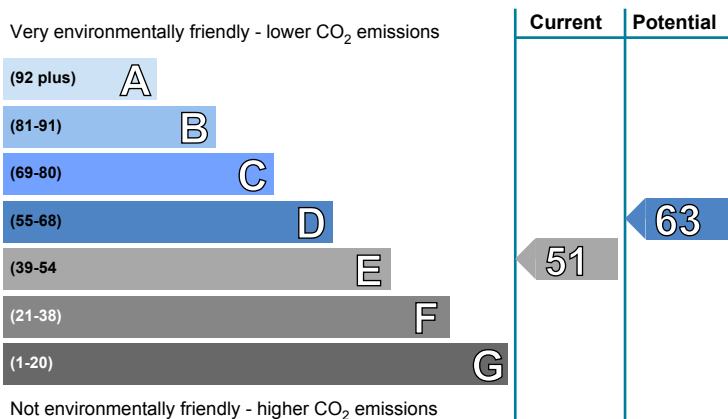
Environmental Impact (CO₂) Rating

This graph shows the effect of your home on the environment in terms of carbon dioxide (CO₂) emissions. The higher the rating, the less impact it has on the environment.
