FLAT 1/2
11 MILLWOOD STREET
GLASGOW
G41 3JY

Home Report

Energy Performance Certificate (EPC)

Single Survey

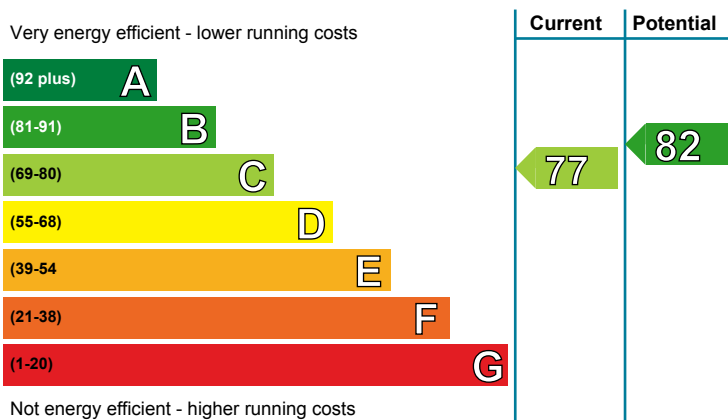
Energy Efficiency Rating

This graph shows the current efficiency of your home, taking into account both energy efficiency and fuel costs. The higher this rating, the lower your fuel bills are likely to be.

Your current rating is **band C (77)**. The average rating for EPCs in Scotland is **band D (61)**.

The potential rating shows the effect of undertaking all of the improvement measures listed within your recommendations report.
