18 BROOMCLIFF
30 CASTLETON DRIVE
NEWTON MEARNS
GLASGOW
G77 5LG

Home Report

Dwelling type: Mid-floor flat
Date of assessment: 19 May 2022
Date of certificate: 19 May 2022
Total floor area: 119 m²
Primary Energy Indicator: 303 kWh/m²/year

Scottish Single Survey

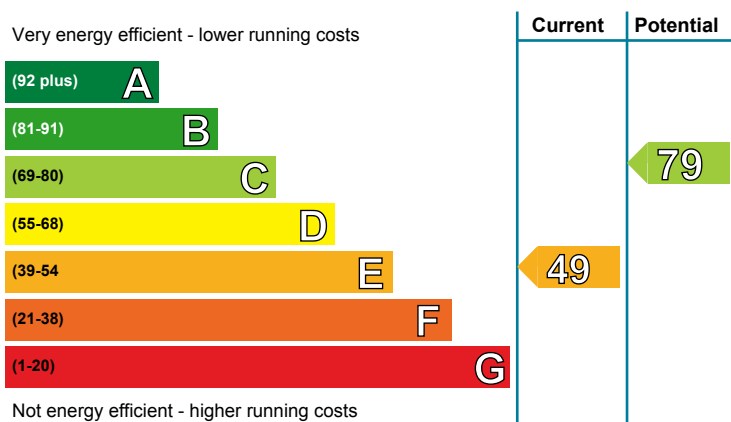
Energy Efficiency Rating

This graph shows the current efficiency of your home, taking into account both energy efficiency and fuel costs. The higher this rating, the lower your fuel bills are likely to be.

Your current rating is **band E (49)**. The average rating for EPCs in Scotland is **band D (61)**.

The potential rating shows the effect of undertaking all of the improvement measures listed within your recommendations report.

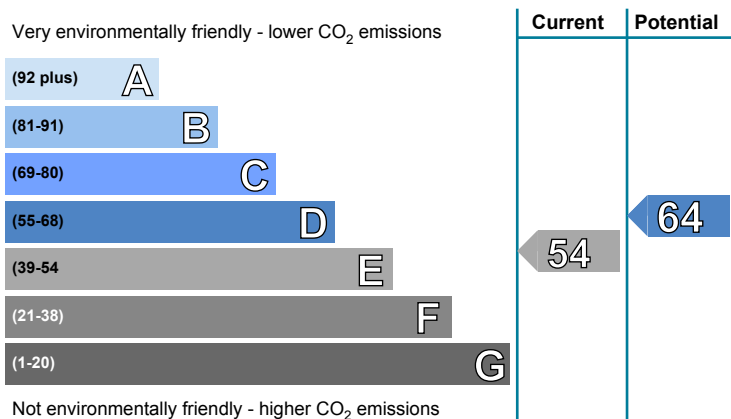
Environmental Impact (CO₂) Rating

This graph shows the effect of your home on the environment in terms of carbon dioxide (CO₂) emissions. The higher the rating, the less impact it has on the environment.

Your current rating is **band E (54)**. The average rating for EPCs in Scotland is **band D (59)**.

The potential rating shows the effect of undertaking all of the improvement measures listed within your recommendations report.
