# HARVEY DONALDSON & GIBSON

## survey report on:

Property address	9B Dornal Drive, Troon, KA10 7JZ	
Customer	Ms A Croucher	
Customer address	9B Dornal Drive, Troon, KA19 7HZ	
Prepared by	Harvey Donaldson and Gibson	
Date of inspection	4th May 2022

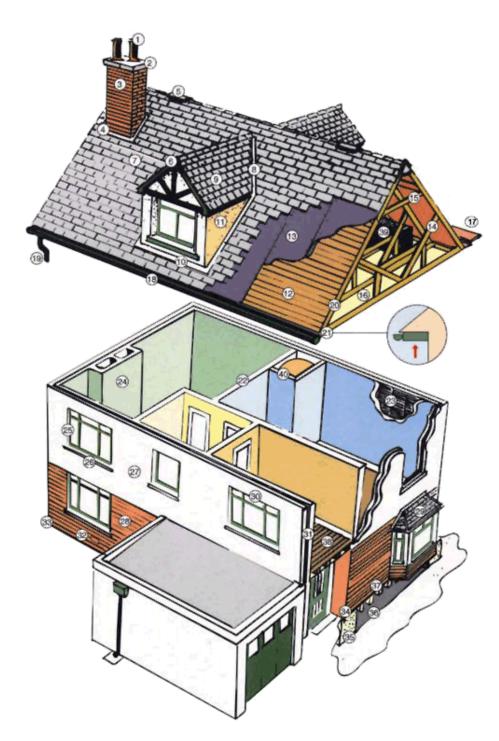
#### Sectional Diagram showing elements of a typical house

Reference may be made in this report to some or all of the above component parts of the property. This diagram may assist you in locating and understanding these items.

- 1) Chimney pots
- 2) Coping stone
- 3) Chimney head
- 4 Flashing
- 5 Ridge ventilation
- 6 Ridge board
- 7) Slates / tiles
- 8 Valley guttering
- 9 Dormer projection
- 10 Dormer flashing
- 11) Dormer cheeks
- 12) Sarking
- 13) Roof felt
- (14) Trusses
- 15) Collar
- (16) Insulation
- 17) Parapet gutter
- (18) Eaves guttering
- Rainwater downpipe
- 20) Verge boards/skews
- 21) Soffit boards
- 22) Partition wall
- 23) Lath / plaster
- 24) Chimney breast
- 25) Window pointing
- 6) Window sills
- 27) Rendering
- (28) Brickwork / pointing
- 29) Bay window projection
- 30 Lintels
- (31) Cavity walls / wall ties
- 32) Subfloor ventilator
- 33) Damp proof course
- 34) Base course
- 35) Foundations
- 36) Solum
- 37) Floor joists
- 38) Floorboards
- 39) Water tank
- 40) Hot water tank
