# Home Report

# Scottish Single Survey

<b>Property address</b>	Flat B 10 Bath Street LARGS KA30 8BL
-------------------------	---

<b>Prepared by</b>	J & E Shepherd Chartered Surveyors
--------------------	------------------------------------

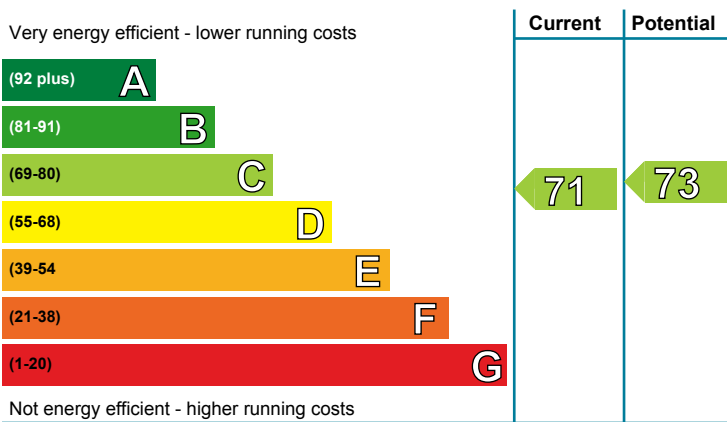
## Energy Efficiency Rating

This graph shows the current efficiency of your home, taking into account both energy efficiency and fuel costs. The higher this rating, the lower your fuel bills are likely to be.

Your current rating is **band C (71)**. The average rating for EPCs in Scotland is **band D (61)**.

The potential rating shows the effect of undertaking all of the improvement measures listed within your recommendations report.

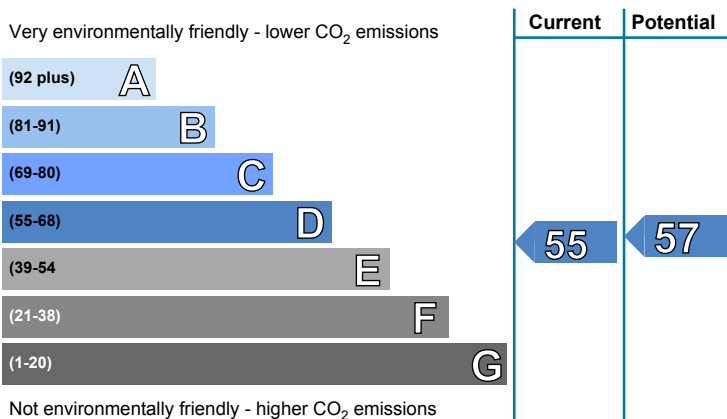
## Environmental Impact (CO<sub>2</sub>) Rating

This graph shows the effect of your home on the environment in terms of carbon dioxide (CO<sub>2</sub>) emissions. The higher the rating, the less impact it has on the environment.
