FLAT 0/2  
122 KENMURE STREET  
GLASGOW  
G41 2NS

# Home Report

FLAT 0/2 , 122 KENMURE STREET, GLASGOW, G41 2NS

# Scottish Single Survey

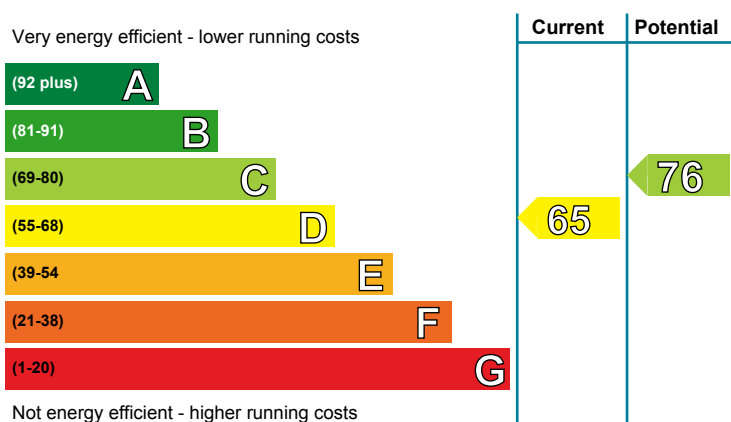
## Energy Efficiency Rating

This graph shows the current efficiency of your home, taking into account both energy efficiency and fuel costs. The higher this rating, the lower your fuel bills are likely to be.

Your current rating is **band D (65)**. The average rating for EPCs in Scotland is **band D (61)**.

The potential rating shows the effect of undertaking all of the improvement measures listed within your recommendations report.

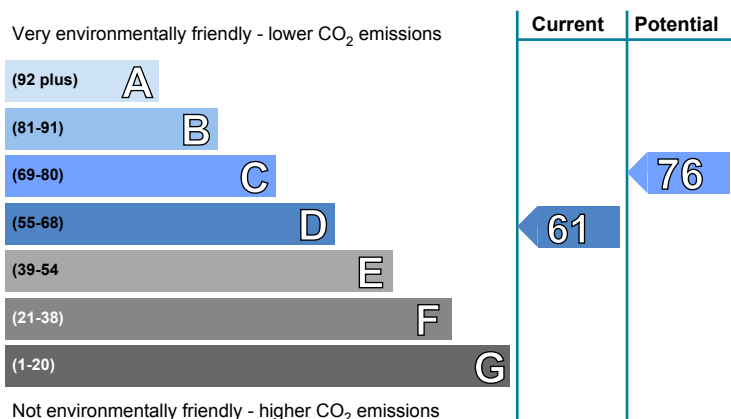
## Environmental Impact (CO<sub>2</sub>) Rating

This graph shows the effect of your home on the environment in terms of carbon dioxide (CO<sub>2</sub>) emissions. The higher the rating, the less impact it has on the environment.

Your current rating is **band D (61)**. The average rating for EPCs in Scotland is **band D (59)**.

The potential rating shows the effect of undertaking all of the improvement measures listed within your recommendations report.
