Home Report

Scottish Single Survey

Property address	2/L 13 Pier Road Fairlie LARGS KA29 0AP
------------------	-----------------------------------------------------

Prepared by	Shepherd Chartered Surveyors
-------------	------------------------------

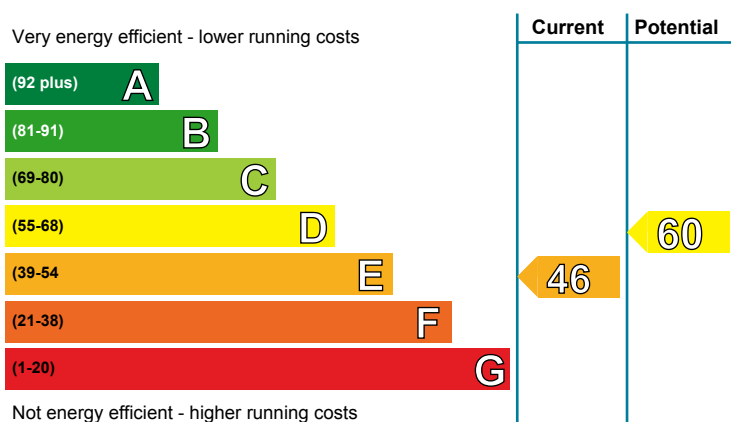
Energy Efficiency Rating

This graph shows the current efficiency of your home, taking into account both energy efficiency and fuel costs. The higher this rating, the lower your fuel bills are likely to be.

Your current rating is **band E (46)**. The average rating for EPCs in Scotland is **band D (61)**.

The potential rating shows the effect of undertaking all of the improvement measures listed within your recommendations report.

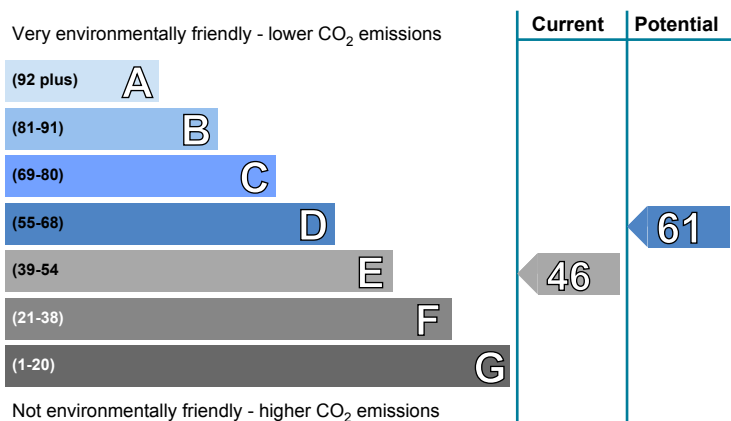
Environmental Impact (CO₂) Rating

This graph shows the effect of your home on the environment in terms of carbon dioxide (CO₂) emissions. The higher the rating, the less impact it has on the environment.
